Sonoma County Final Villa Grande Drainage Study December 2022

Job # SONO.01

PREPARED FOR: County of Sonoma 2300 County Center Dr Santa Rosa, CA 95403 Project #E20010

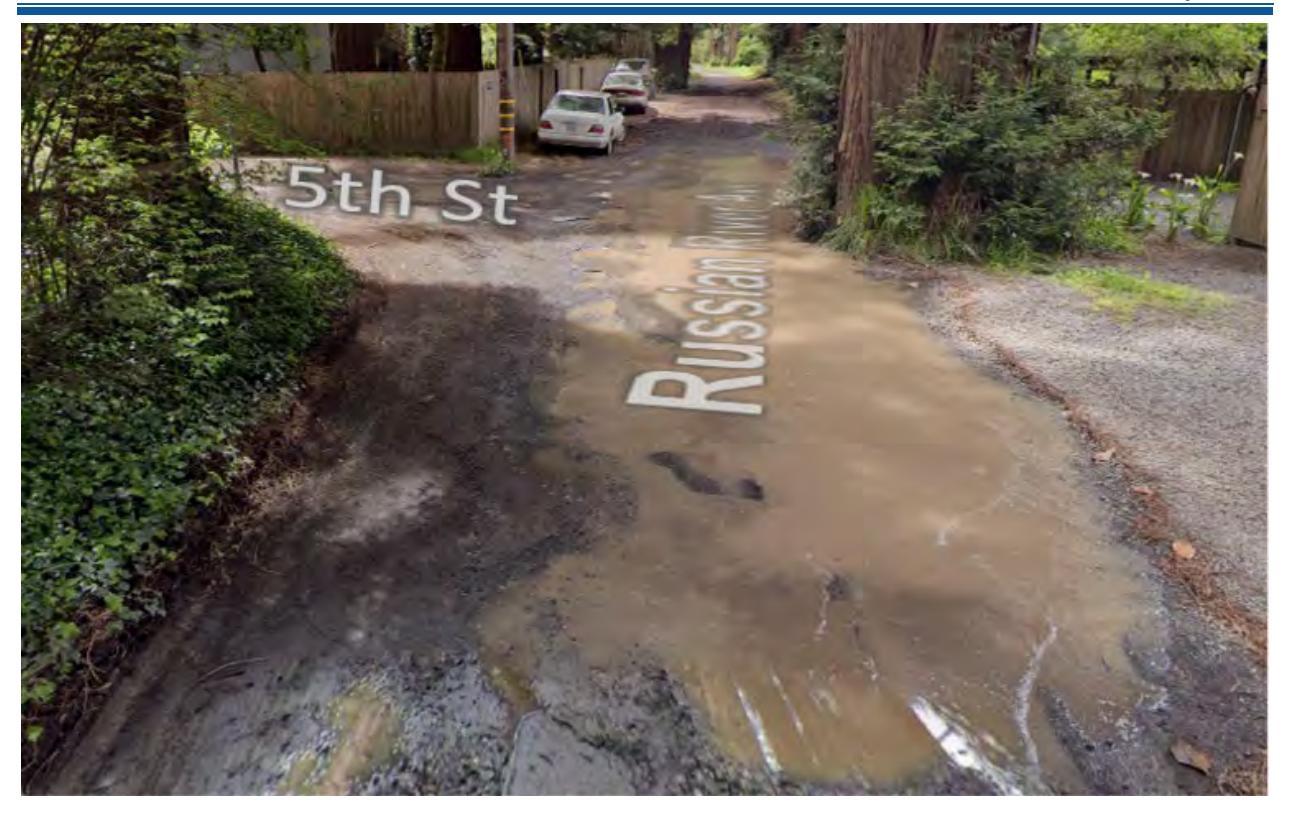
Figure 5-3: Ponded Water at Russian River Ave & 5th Street

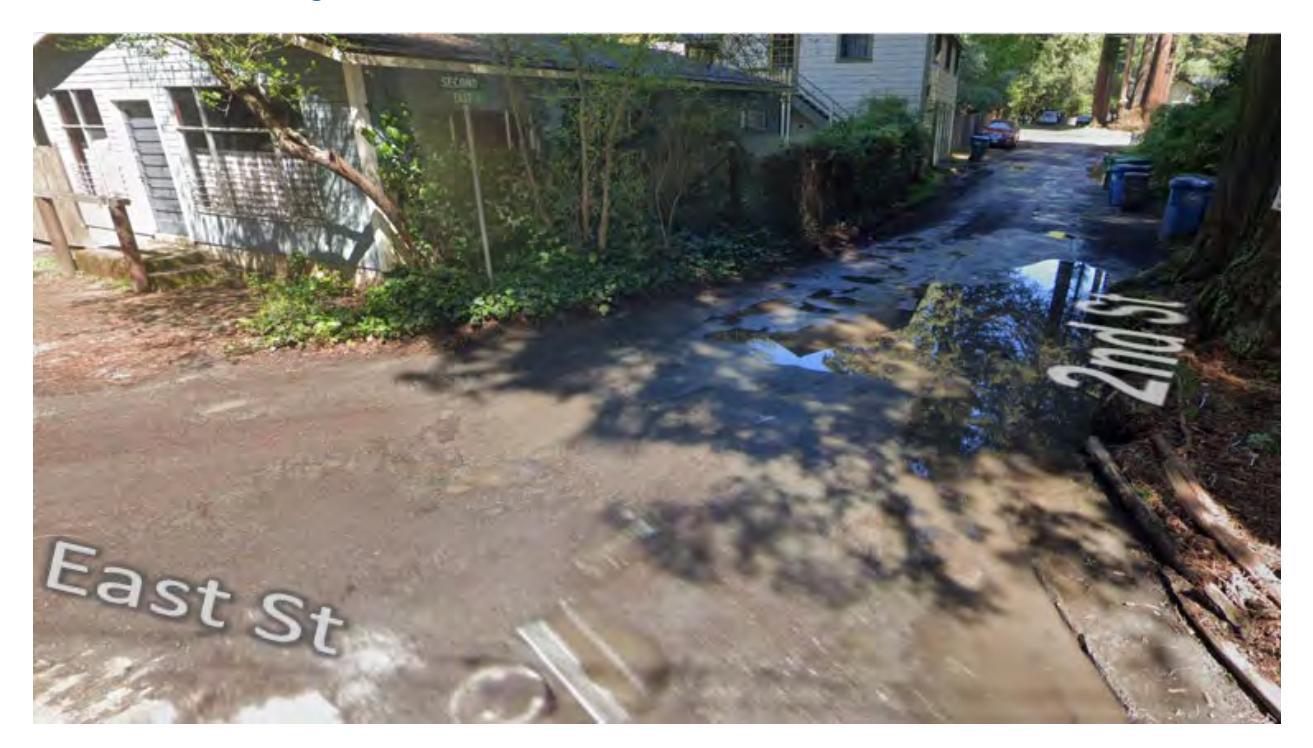
Figure 5-4: Ponded Water at East Street and 2nd Street

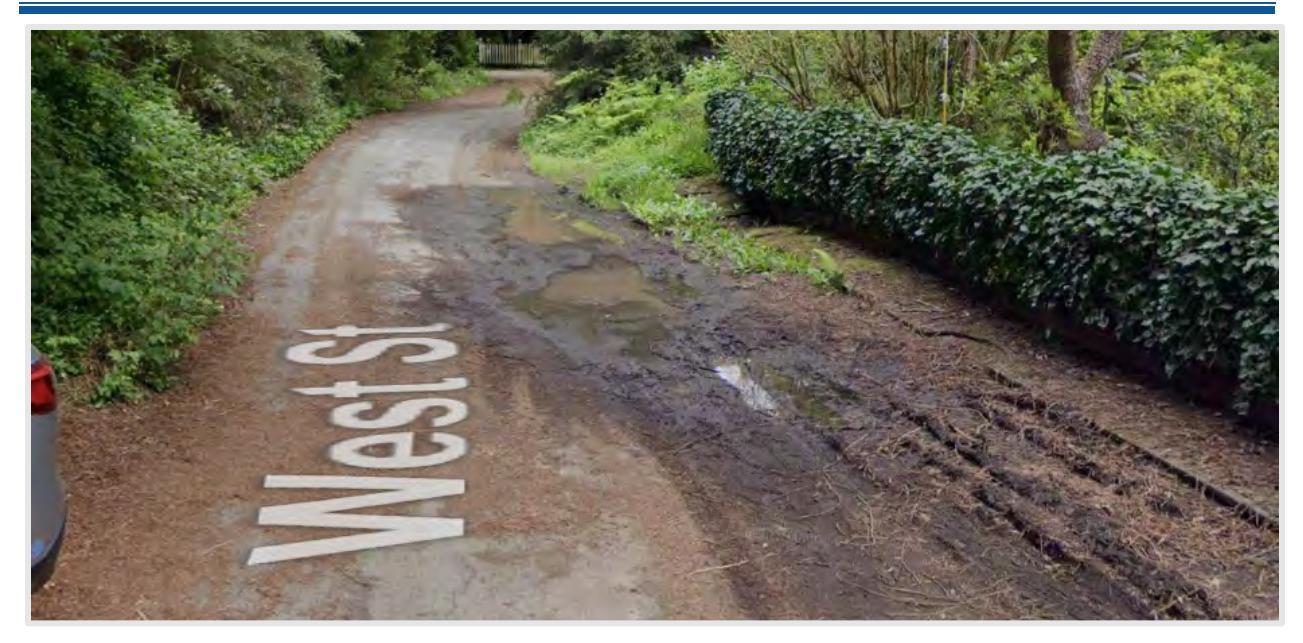
Figure 5-5: Ponded Water and Sediment Buildup on West Street (Between Post Office and East St)

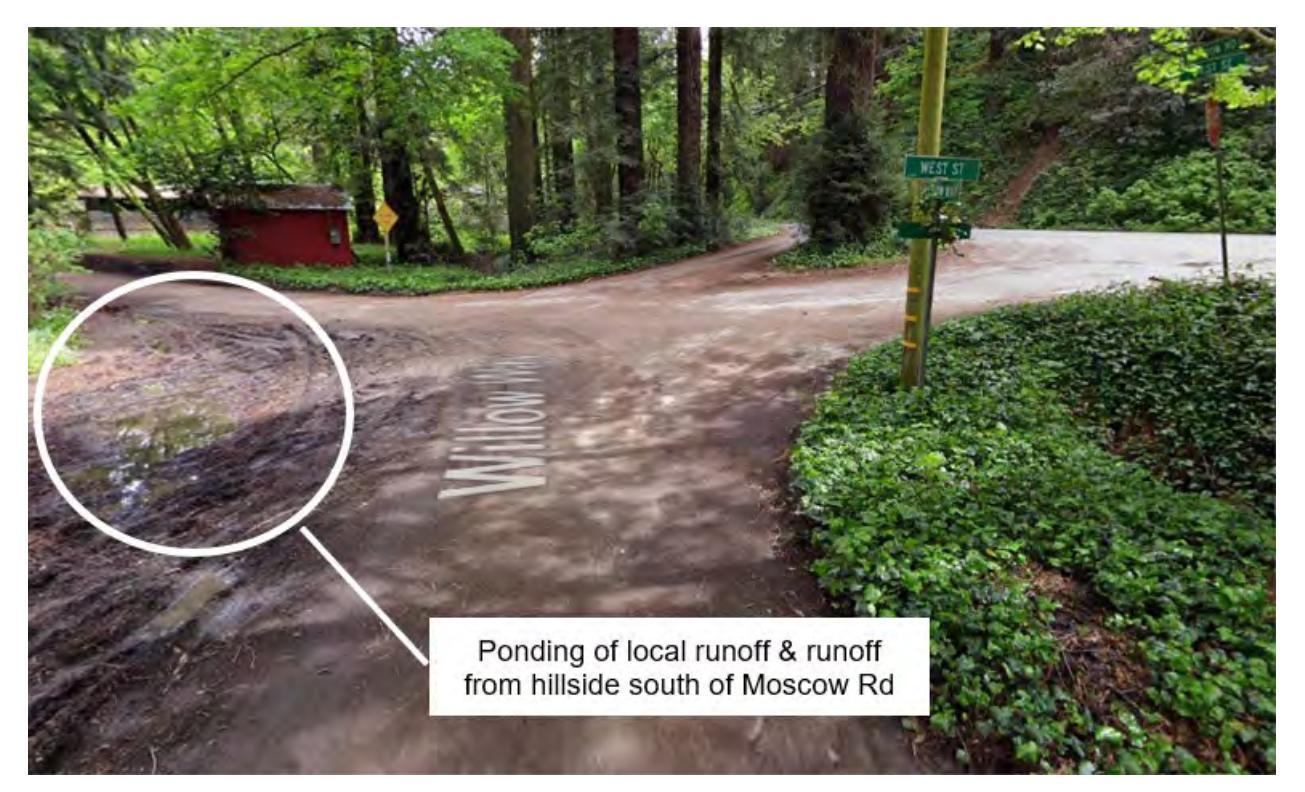
The County identified another location where an additional inlet would be beneficial, on West Street near Willow Road. This is where runoff from Moscow Road tends to run down West Street and pond before entering the ditch system. This is shown in Figure 5-6.

Figure 5-6: Low Point at Willow Road where Runoff from Moscow Road Accumulates

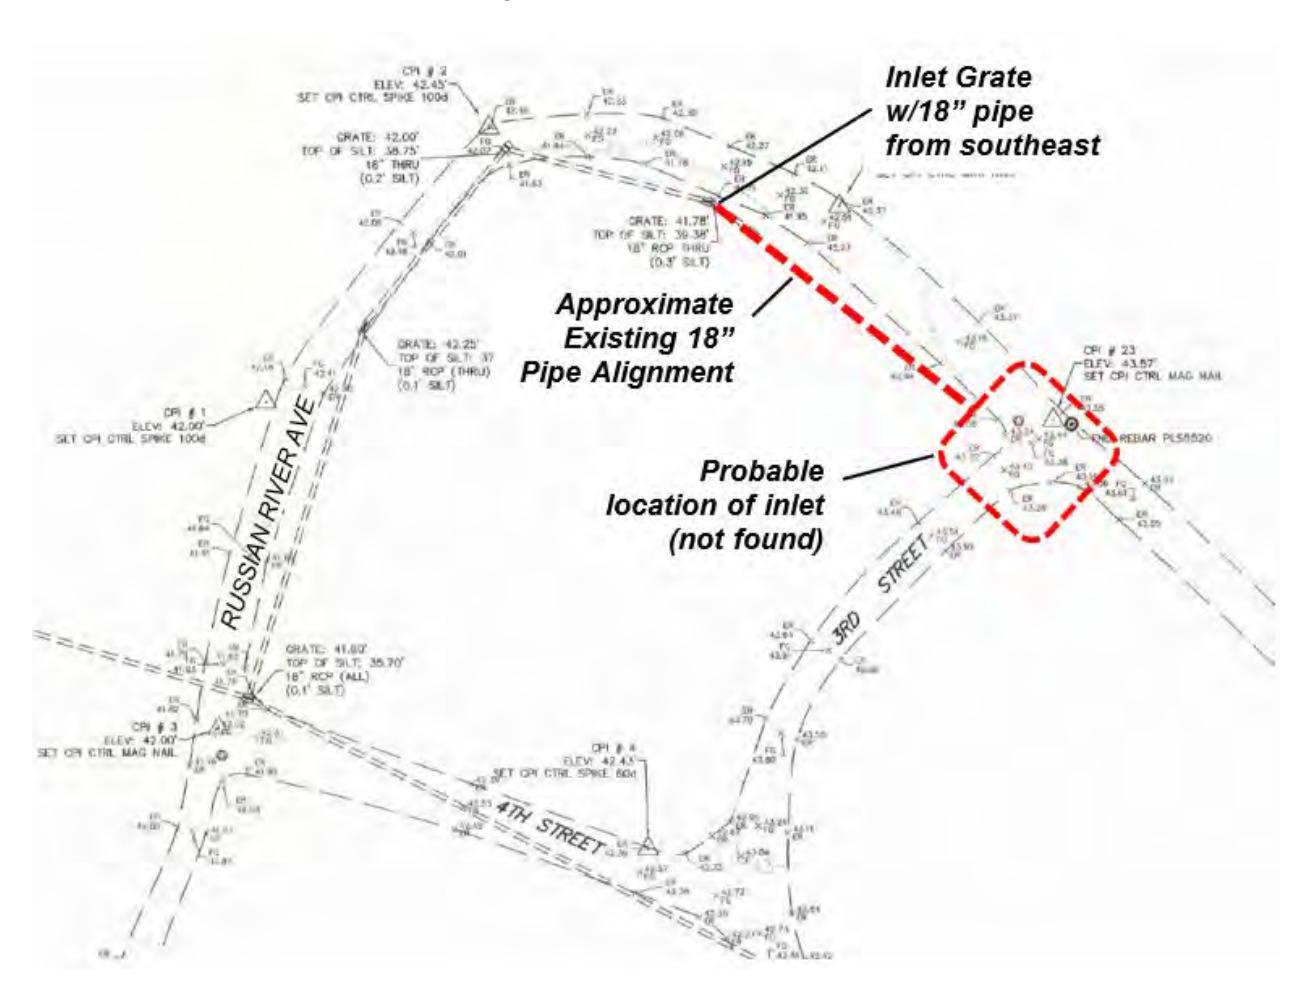
Figure 5-17: Surveyed System Around 3rd Street Annotated with Probable Missing Inlet Location.

Attempts to inspect this system and locate the inlet were not successful, as the grates appear to be rusted in place. It's recommended that the catch basins along Russian River Ave be repaired so that grates can be removed, then CCTV be performed on the system. If an inlet can be located, a smaller project should be undertaken that restores it or relocates to a position where it might be more effective at capturing local runoff and conveying it to the 4th Street outfall in the existing pipe system, which has adequate capacity available.

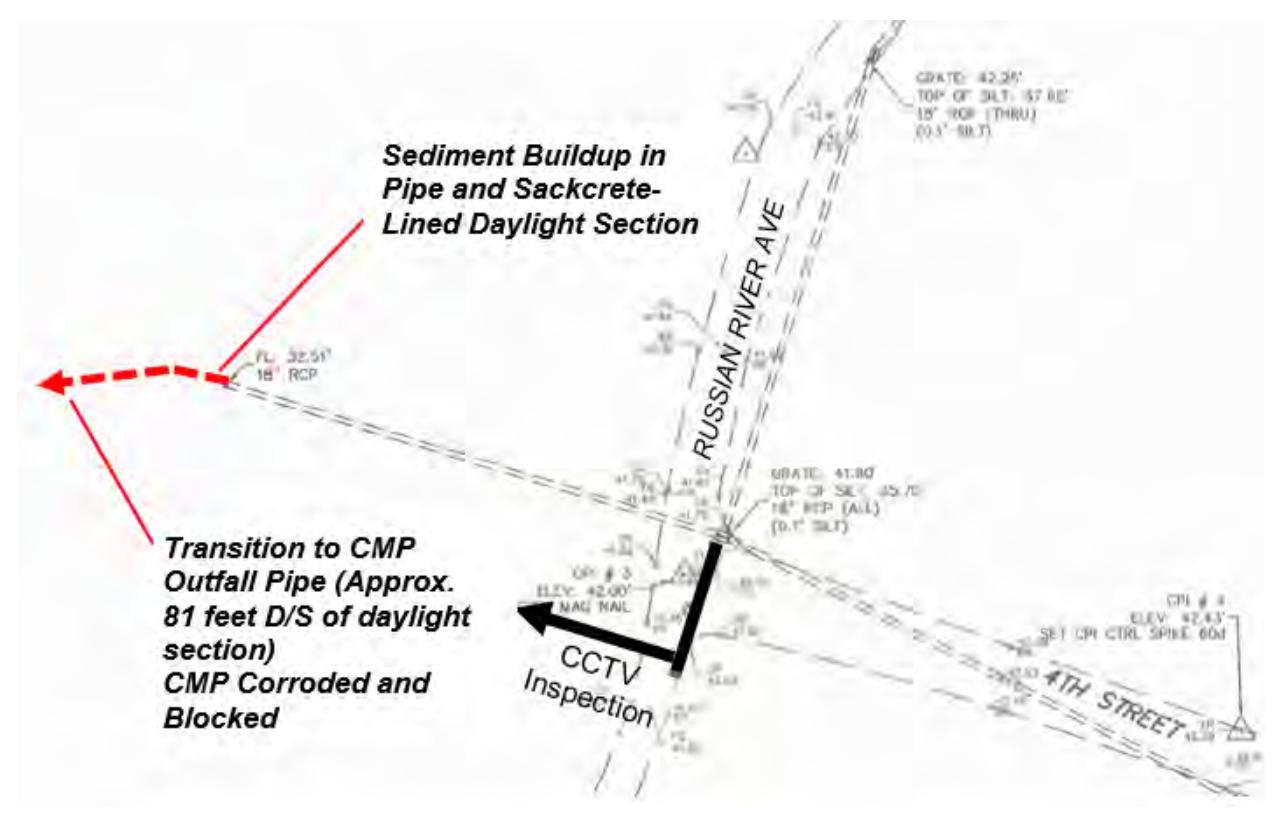
The 4th Street system was inspected west of Russian River Ave (Figure 5-25). The 24-inch RCP pipe appears to be in good condition but requires some removal of built-up sediment and debris in order to maintain its capacity (Figure 5-26). Downstream, however, the pipe transitions to a 32-inch CMP with a corroded bottom (Figure 5-27). It's not likely that this will cause flooding in its current condition, as there is a significant drop in invert elevation to the outfall. However, this should be monitored closely for further failure and prioritized for replacement.

Figure 5-25: 4th Street Outfall System

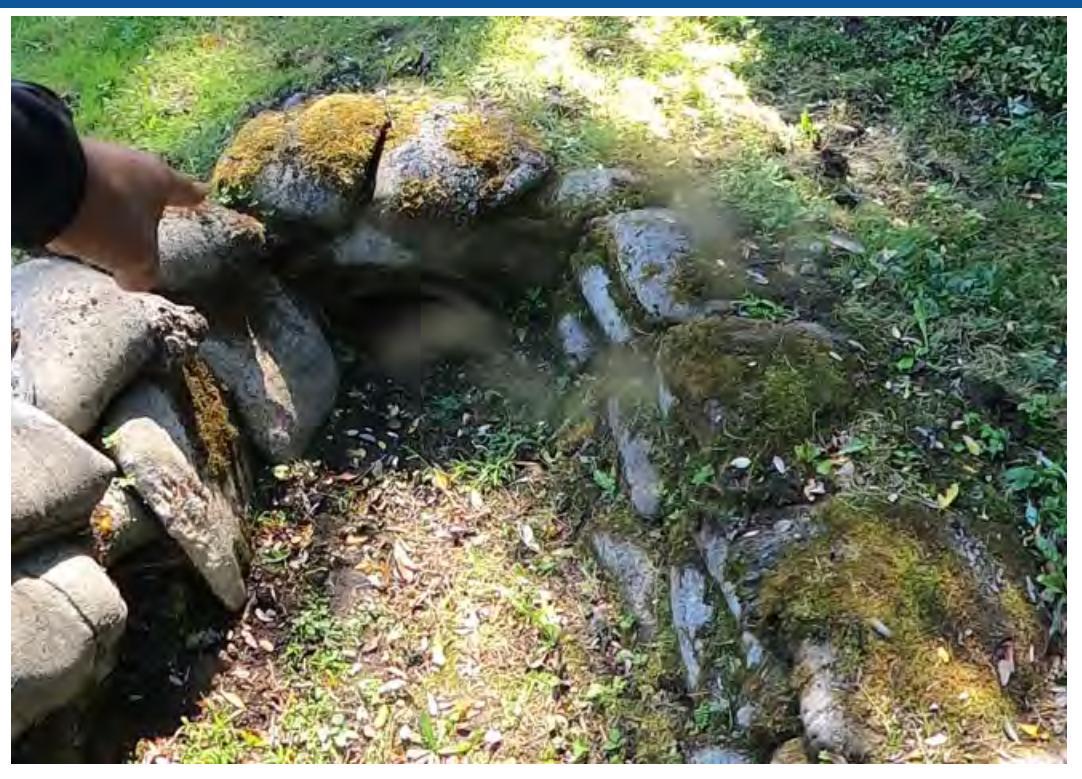
Figure 5-26: 4th Street Outfall Daylight Section Sediment Buildup

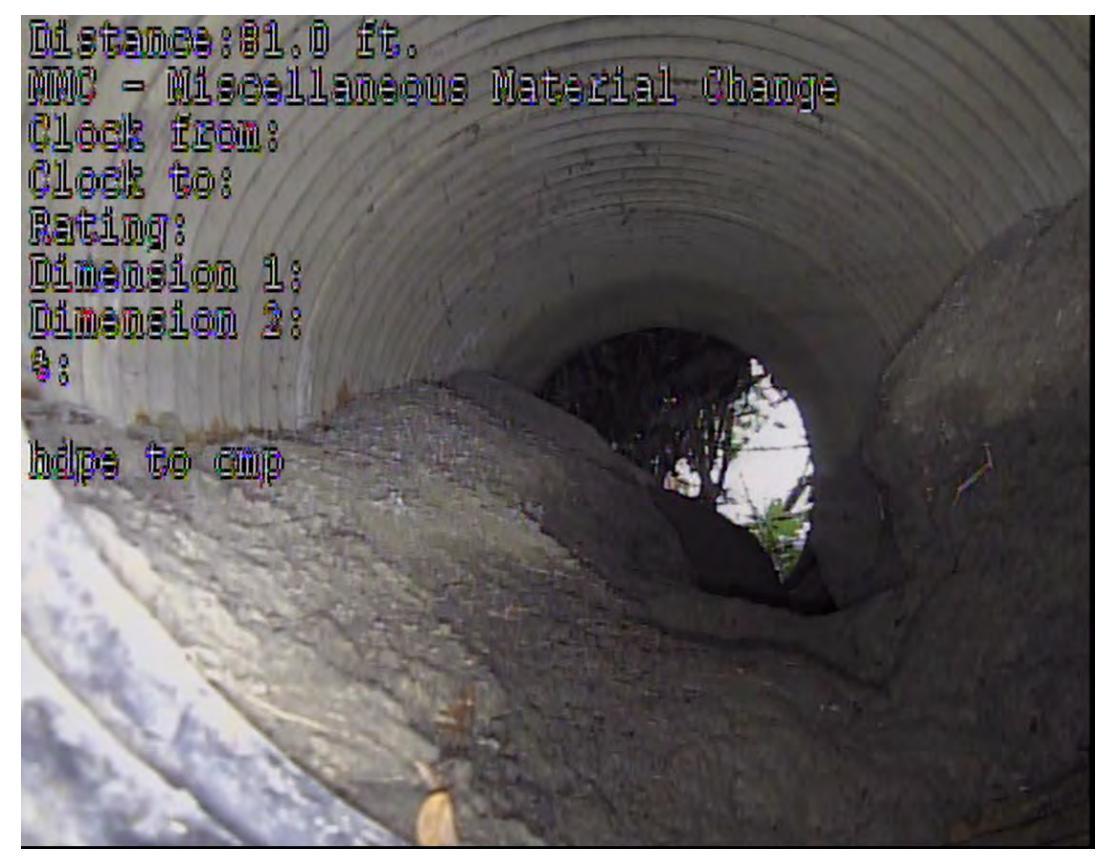
Figure 5-27: Corroded CMP and Outfall Blockage (4th Street Outfall)

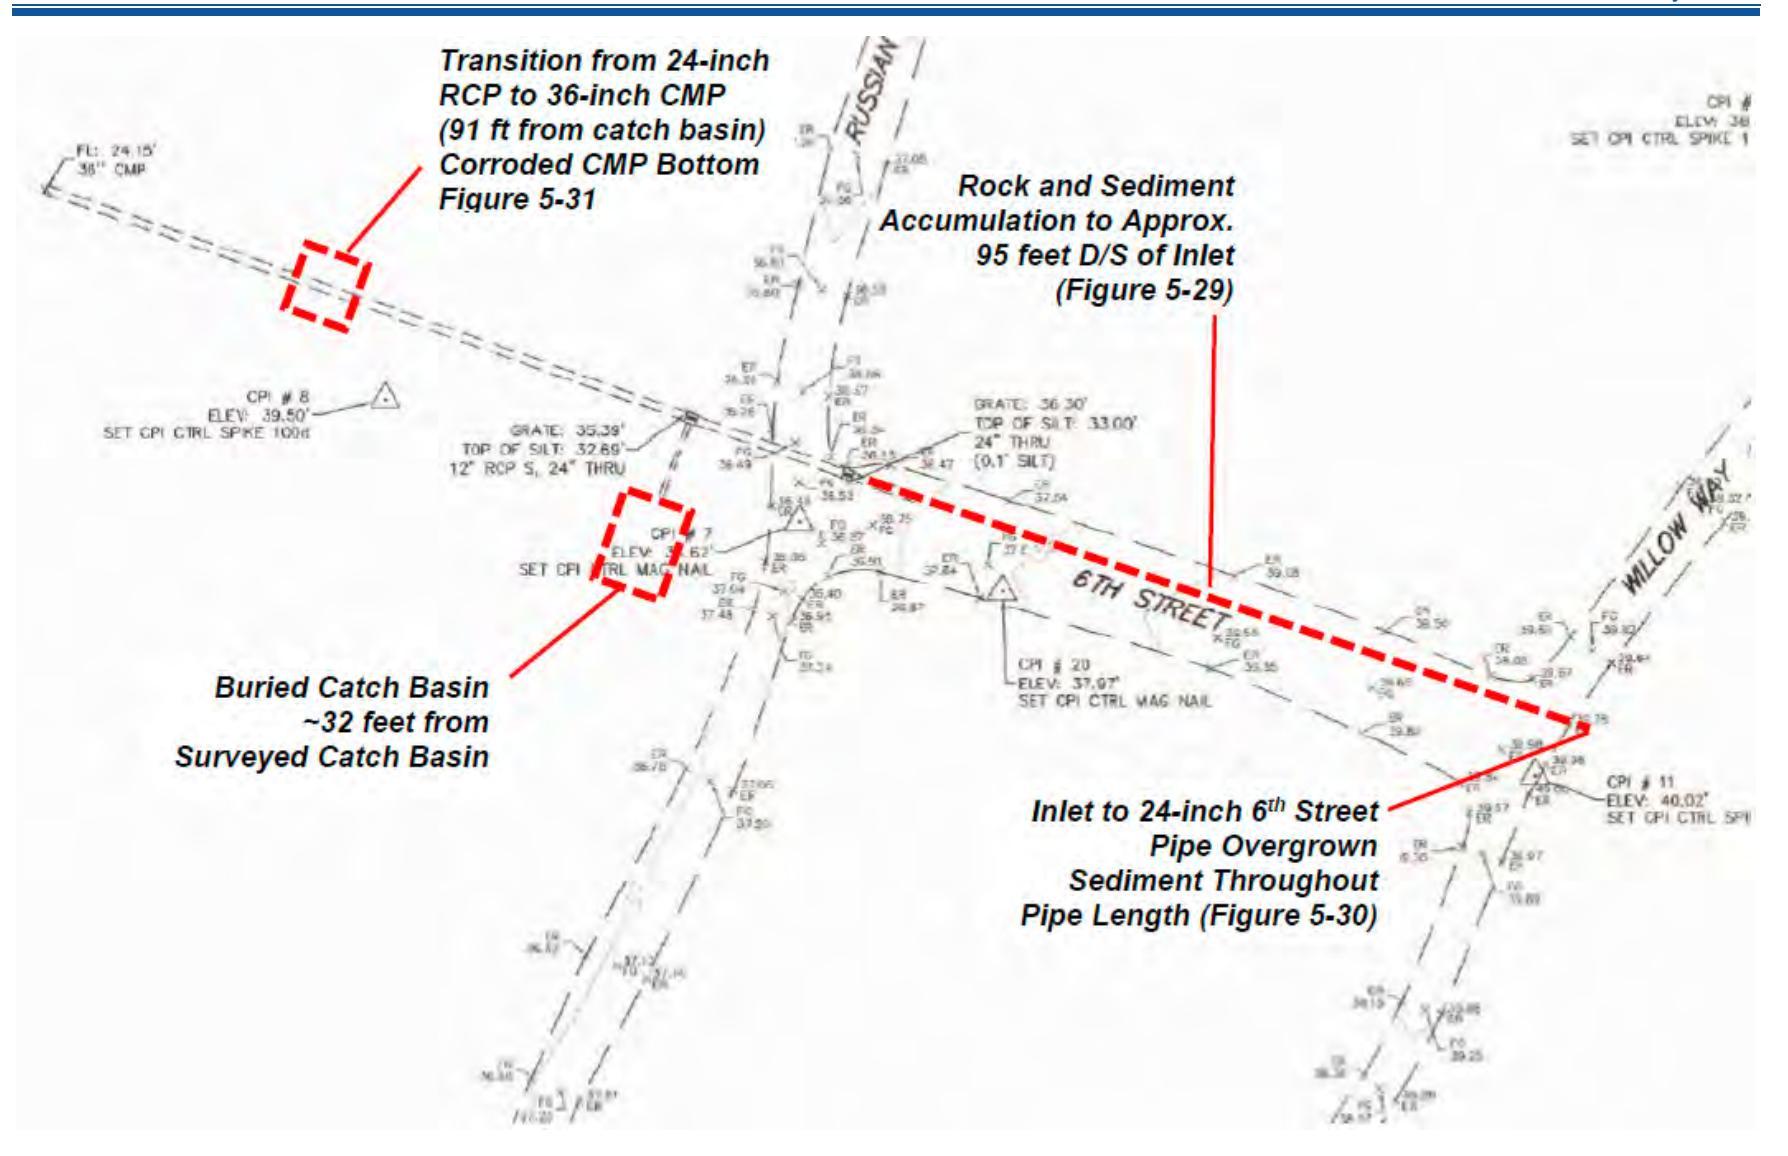
Figure 5-28: 6th Street System Condition

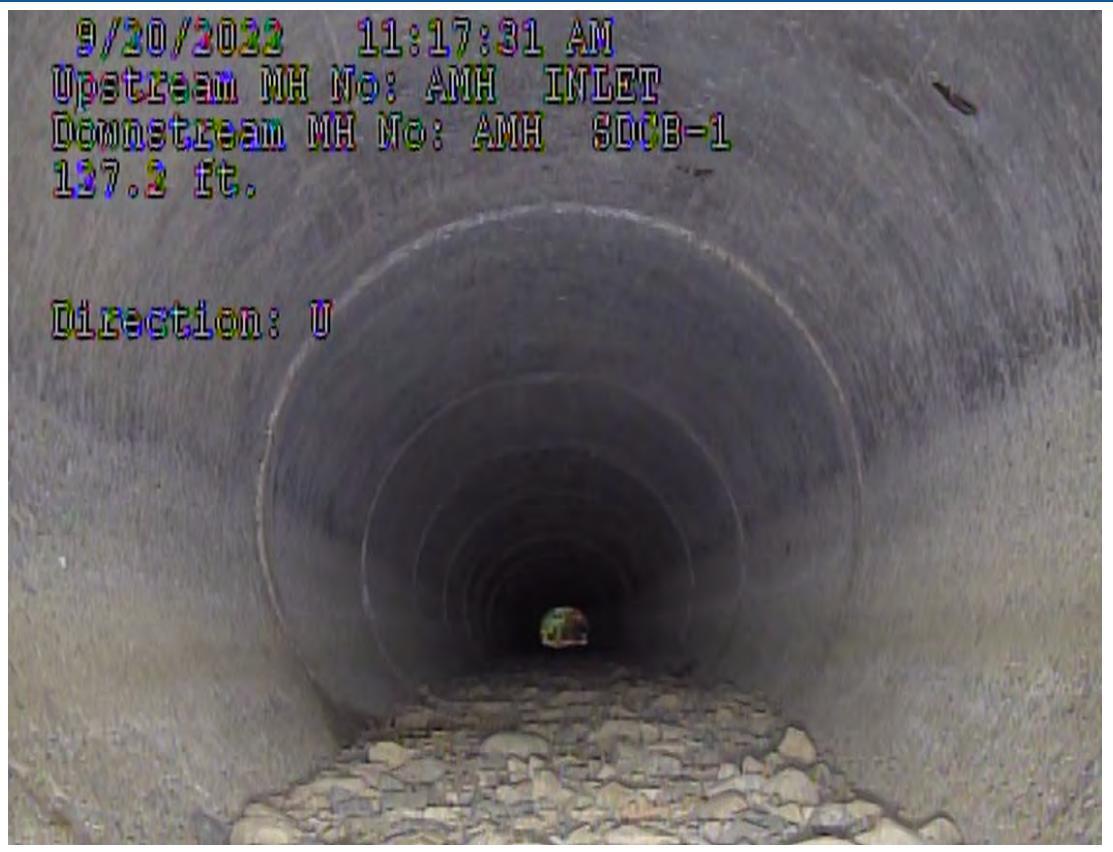
Figure 5-29: Rock and Sediment Accumulation in 6th Street RCP

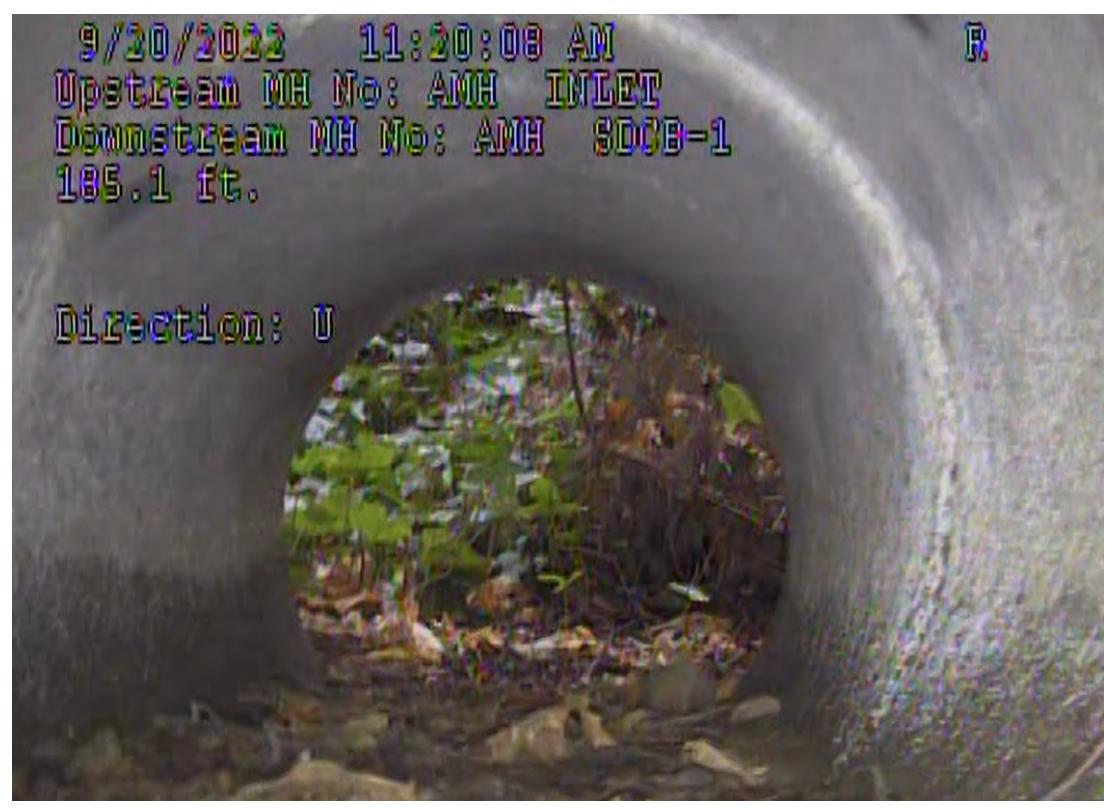
Figure 5-30: Overgrowth and Sediment Accumulation at Upstream end of 6th Street (24-inch RCP)

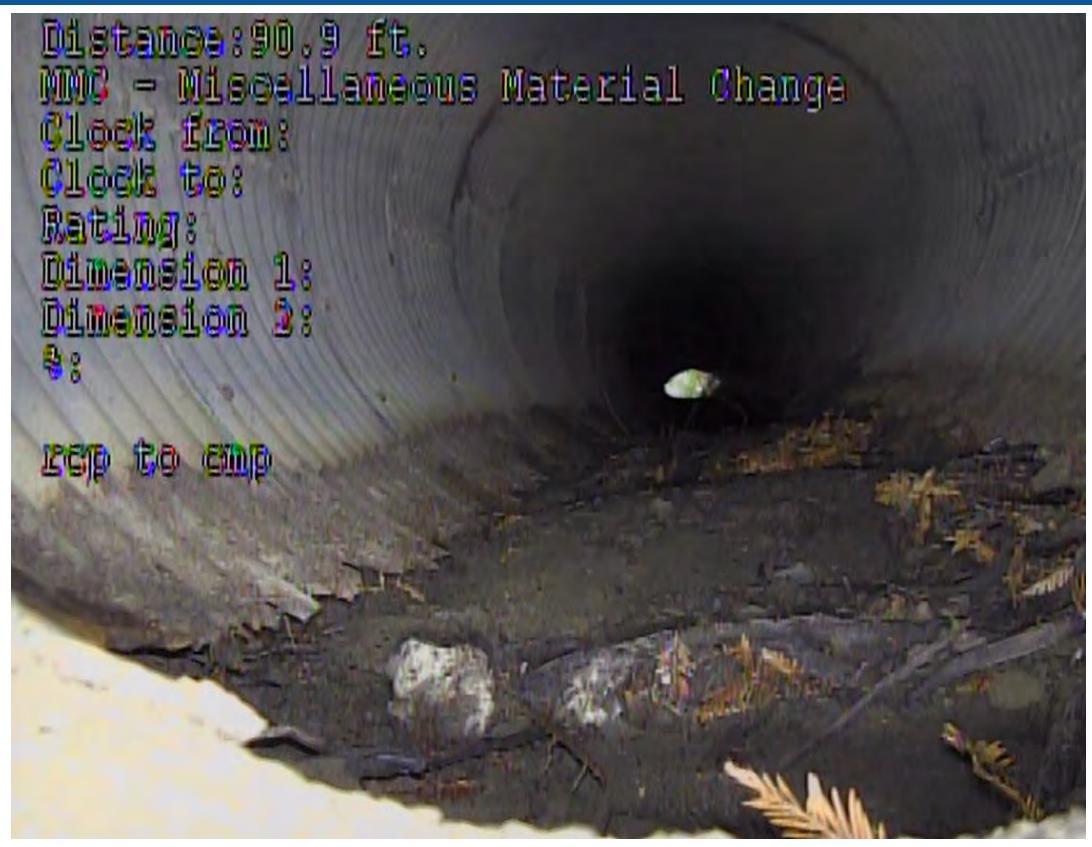
Figure 5-31: Corroded CMP Bottom at Transition from RCP to CMP (6th Street Outfall)

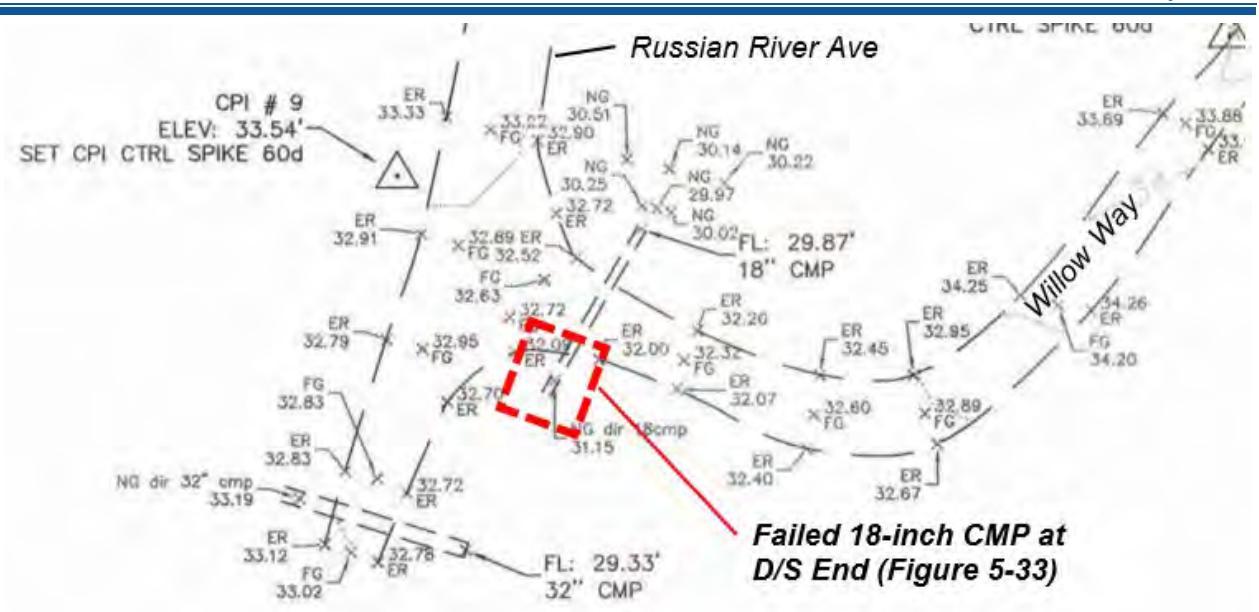
The full length of the 32-inch CMP was inspected. It is generally clear of blockage and in fair condition. This culvert transitions to a 36-inch HDPE approximately 20 feet from its upstream end. There is some corrosion along the invert of the CMP. This culvert has been identified as undersized and is already part of the Willow Way capacity CIP.

Figure 5-32: Willow Way Culverts

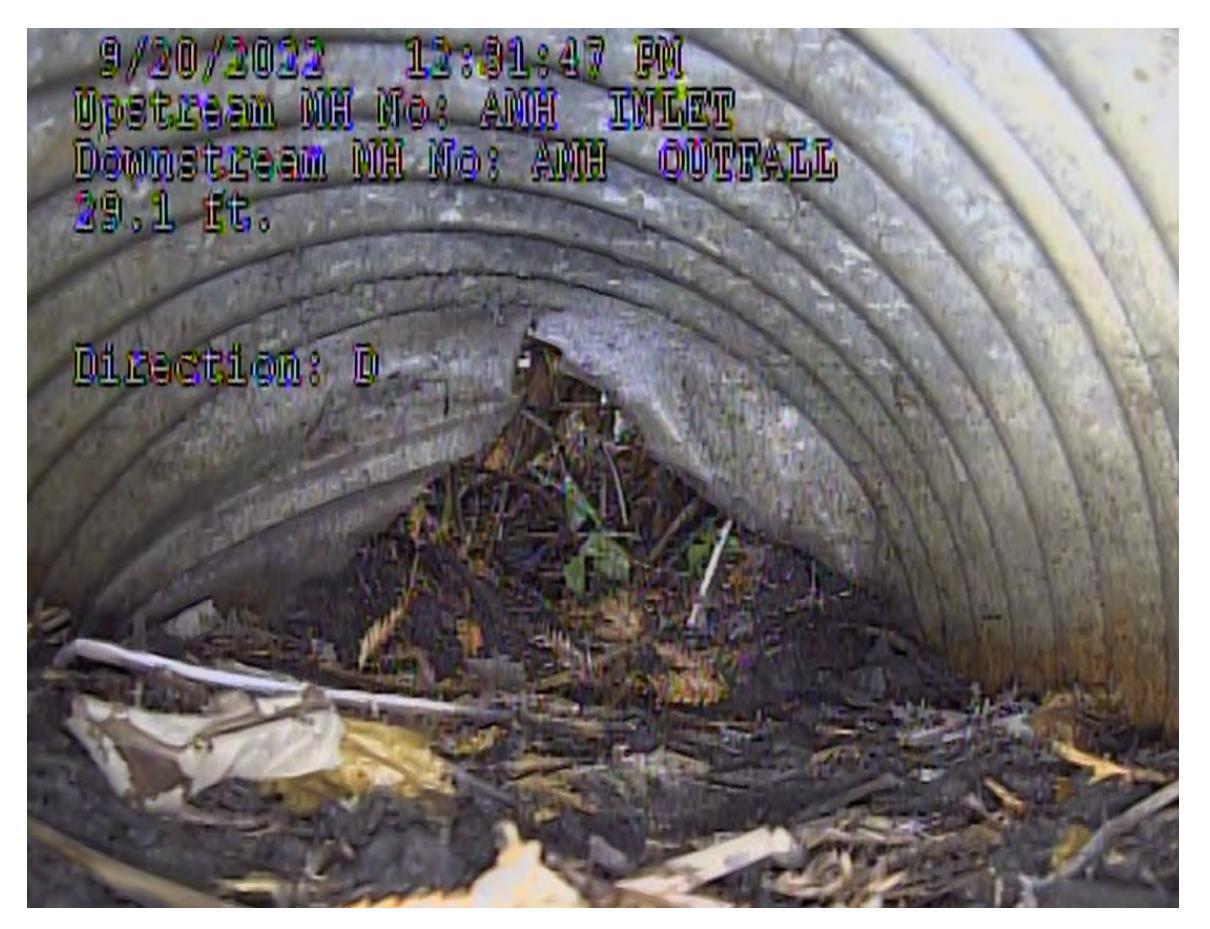
Figure 5-33: Failed 18-inch CMP Culvert at Willow Way (Downstream End)

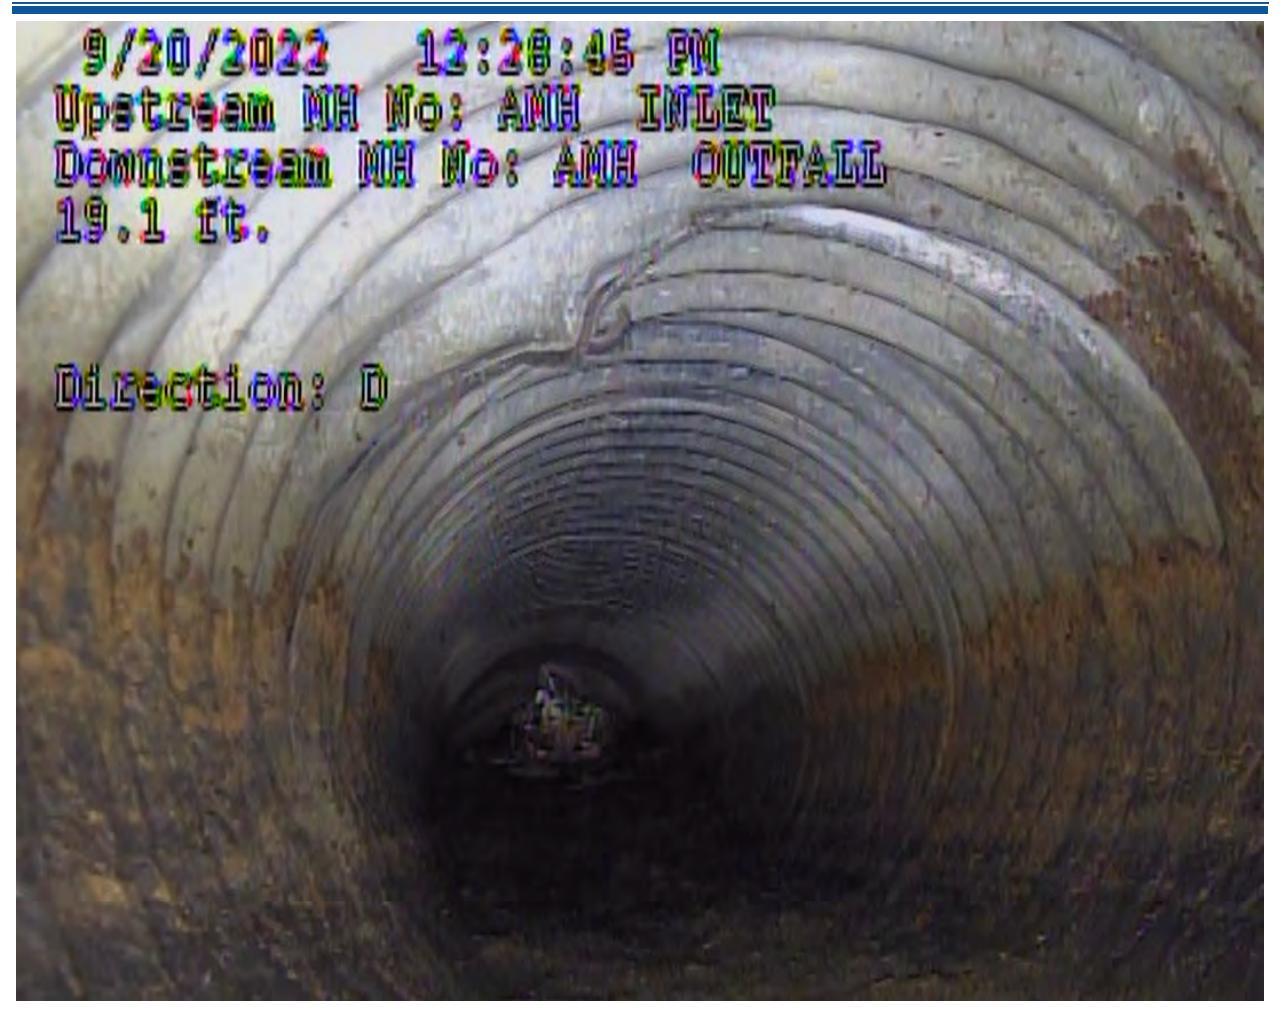
Figure 5-34: Creasing/Flexure and Corrosion in 18-inch CMP Crossing Willow Way.
