Sonoma County Final Villa Grande Drainage Study December 2022

Job # SONO.01

PREPARED FOR: County of Sonoma 2300 County Center Dr Santa Rosa, CA 95403 Project #E20010

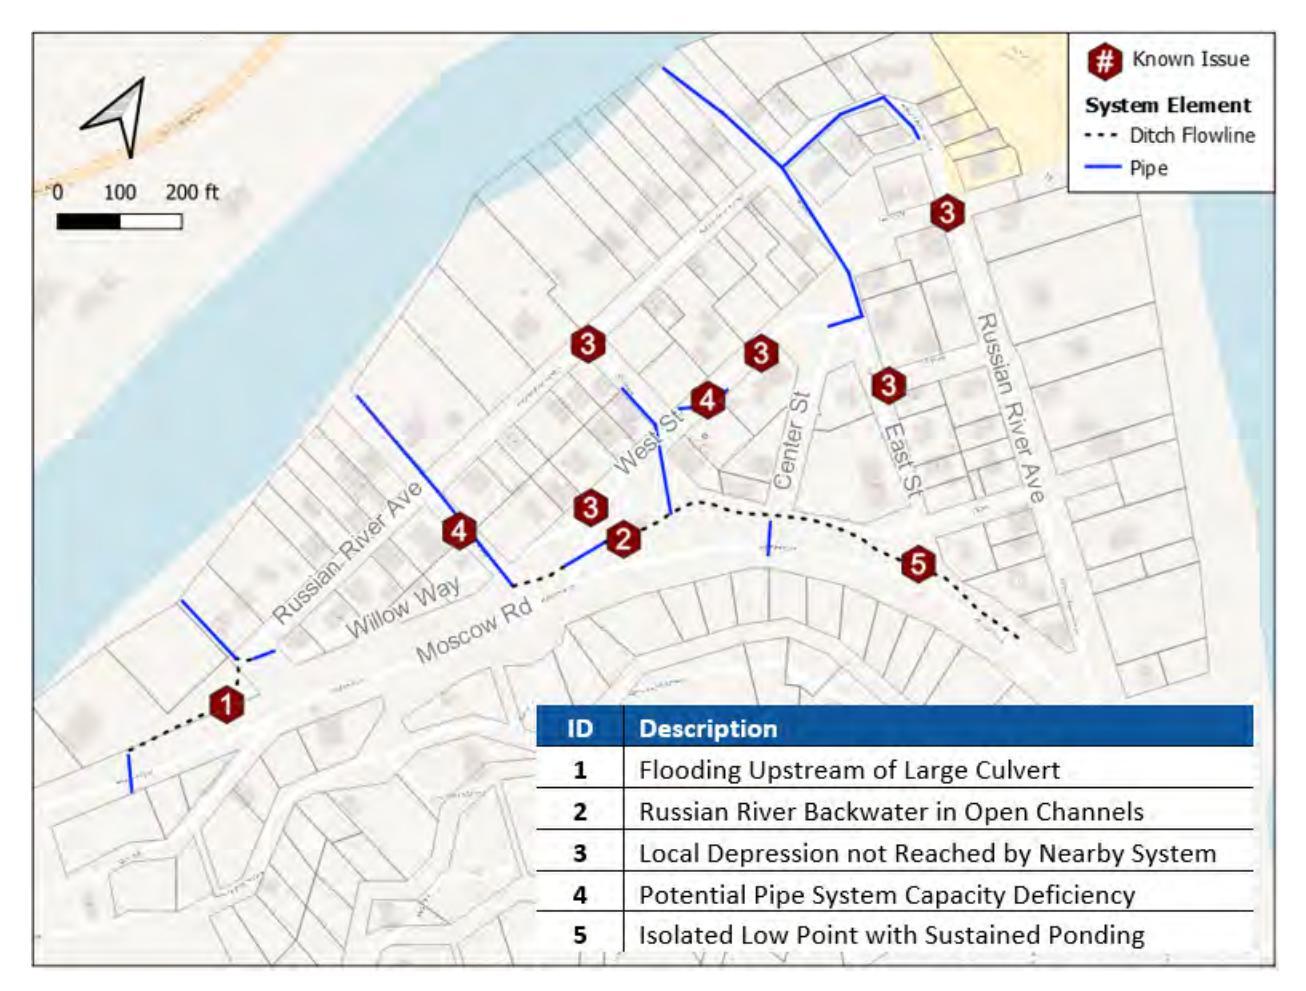
- Certain elements in the system don't appear to be functioning, whether due to blockages, failures, or simply undersized pipe. Specific locations include:
 - Pipes and inlets near the Post Office
 - Culvert(s) at the south end of Willow Way
 - The system along 6th Street that carries runoff from Willow Way to the River
 - Large area of ponding on the north side of Moscow Road, east of the bend in Center Street
- There are spots that tend to remain ponded after even small storms for extended periods of time
- There may be issues with backwater from the Russian River affecting the system. Backwater has been observed in the ditches parallel to Moscow Road.

Figure 5-1: Map of Drainage Issues Identified by the Community, County Staff, and Others.

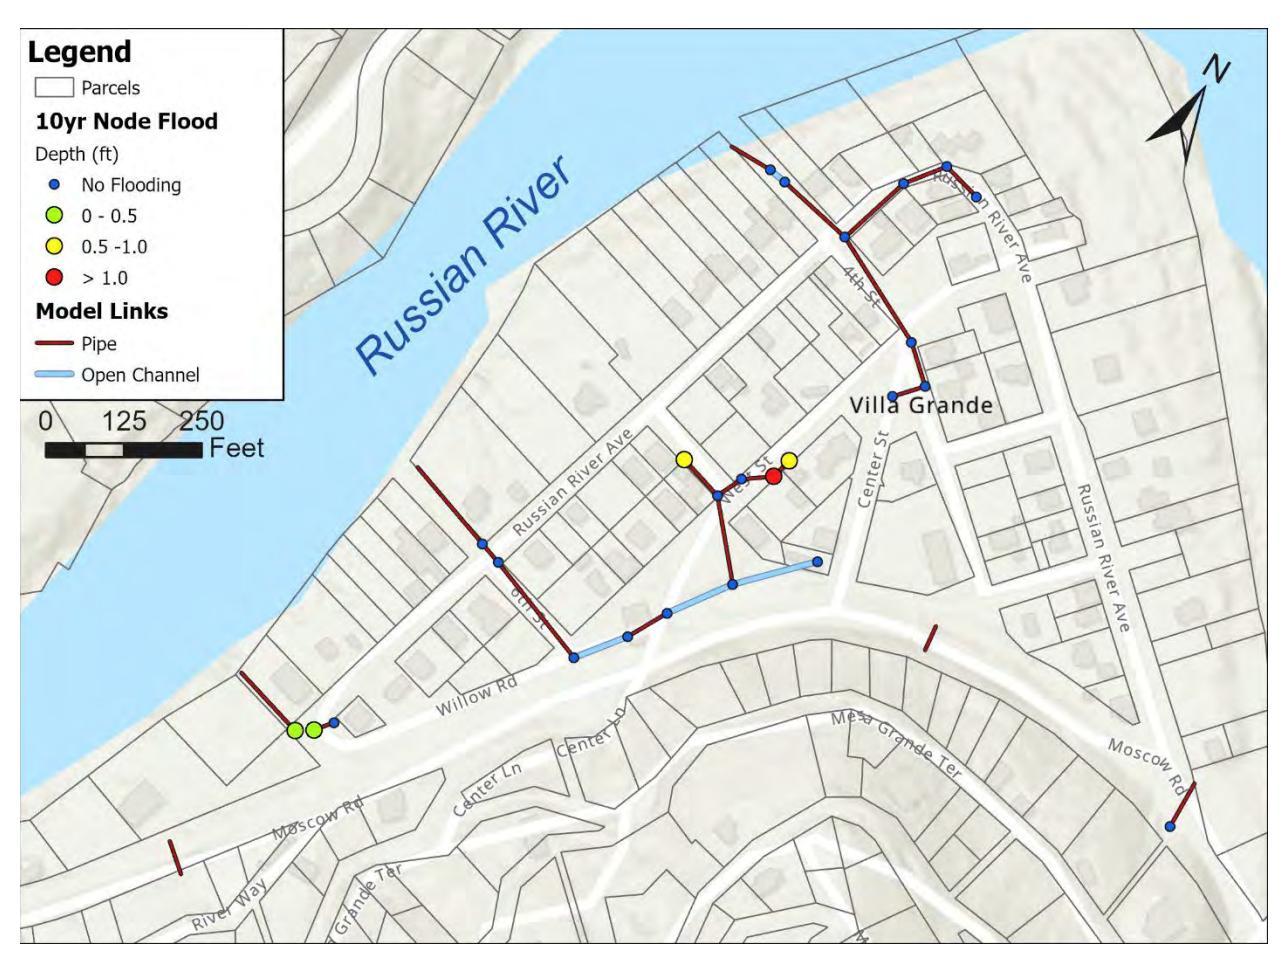
Figure 5-2: Existing System 10-year Node Flood Result from MIKE+

While the northern system appears to have no conveyance capacity issues in the 10-year event, the southern system lacks capacity in its upper reaches, near the post office on West Street and along 5th Street. The two culverts at the south end of Willow Way also appear to surcharge significantly

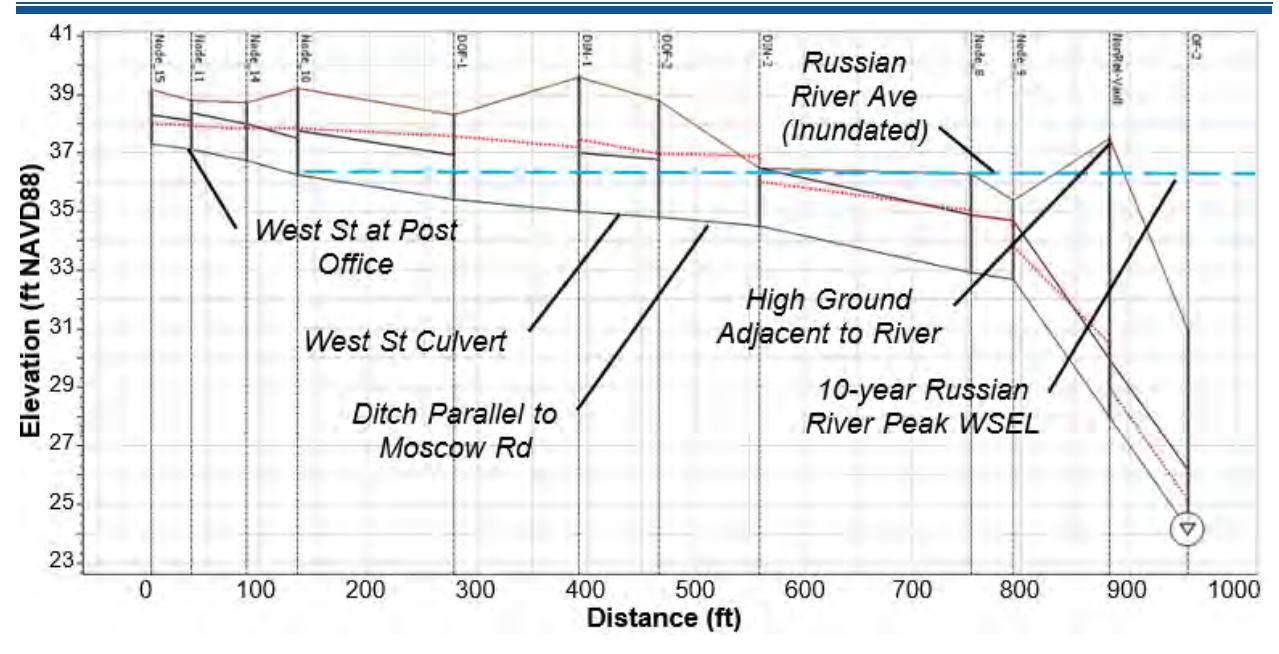
Based on topographic information available to us, it appears that high ground near the river would protect most of the community from a 10-year water surface in the River. However, the 6th Street system has inlets with ground surfaces at roughly 35.4 and 36.3. The culvert crossing West Street at the entrance to the community (which also drains to the 6th Street outfall) has a flow line at roughly elevation 35, allowing river water as far back as Moscow Road at a 10-year peak WSEL. A 10-year profile through the 6th Street system is shown in Figure 5-7.

Figure 5-7: System Profile from West Street to 6th Street Outfall.

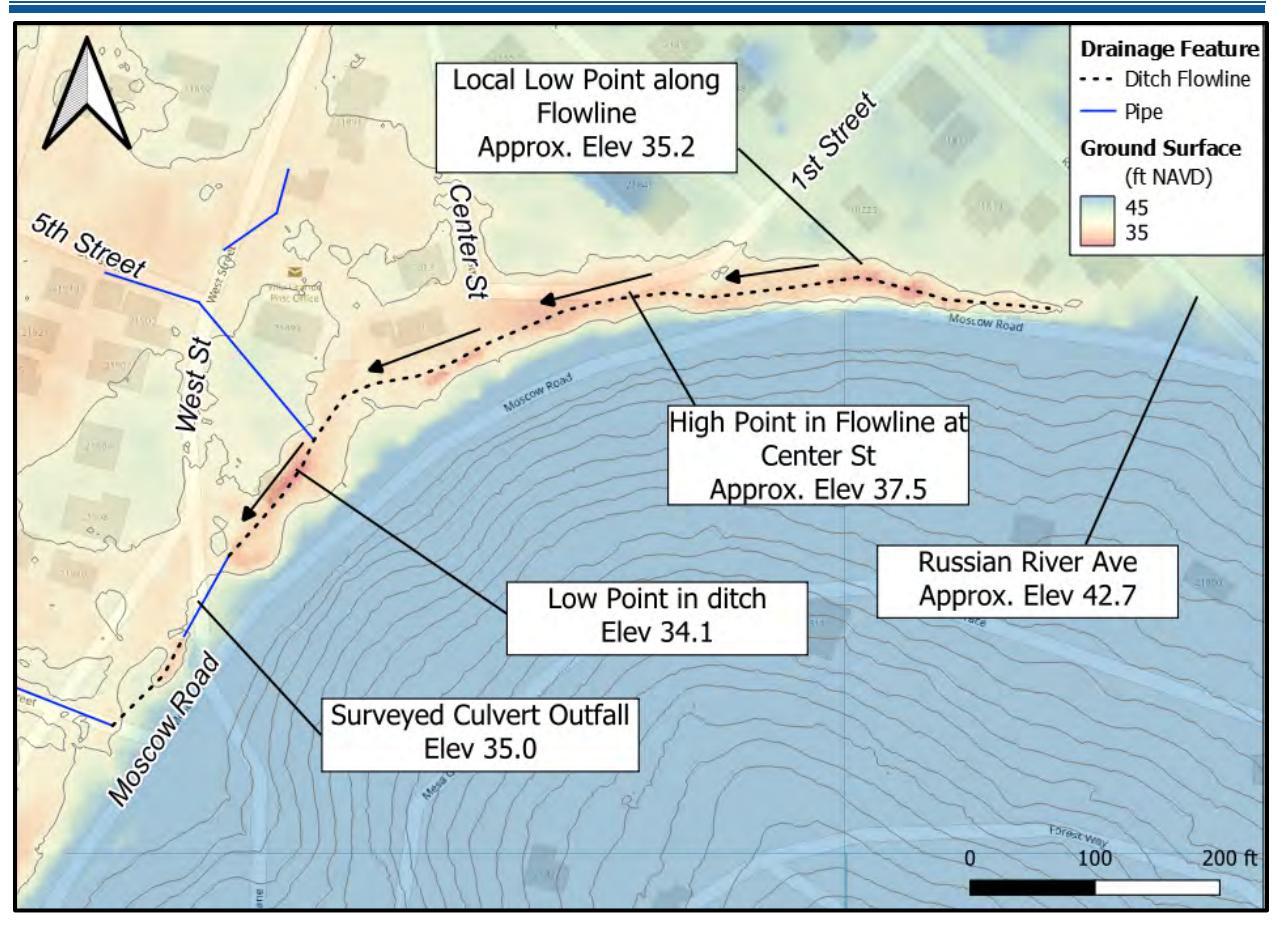
The community also identified an issue with drainage adjacent to Moscow Road near Center Street that is more difficult to evaluate with a model or calculation. This instead requires a more holistic approach to identifying the cause of the issue. Residents noted that after storms, sheet flow from Moscow Road enters the ditch to the north, adjacent to private properties, where it ponds and does not appear able to drain. The first step in evaluating this problem is examining the topography in the area. While survey isn't available across the entire community, 2017 Sonoma County LiDAR topography is available and can be used here. This is shown in Figure 5-8.

The model simply assumes all of the drainage that accumulates at this location makes it further downstream to the West St Culvert and 6th Street outfall. This is an important modeling assumption to ensure that the system downstream has adequate capacity to convey this drainage. Solutions to this issue are explored separately from other pipe system capacity improvements that would allow this impounded runoff to drain more freely.

Figure 5-8: Ditch Flowline Between 6th Street and Russian River Ave, Parallel to Moscow Road.

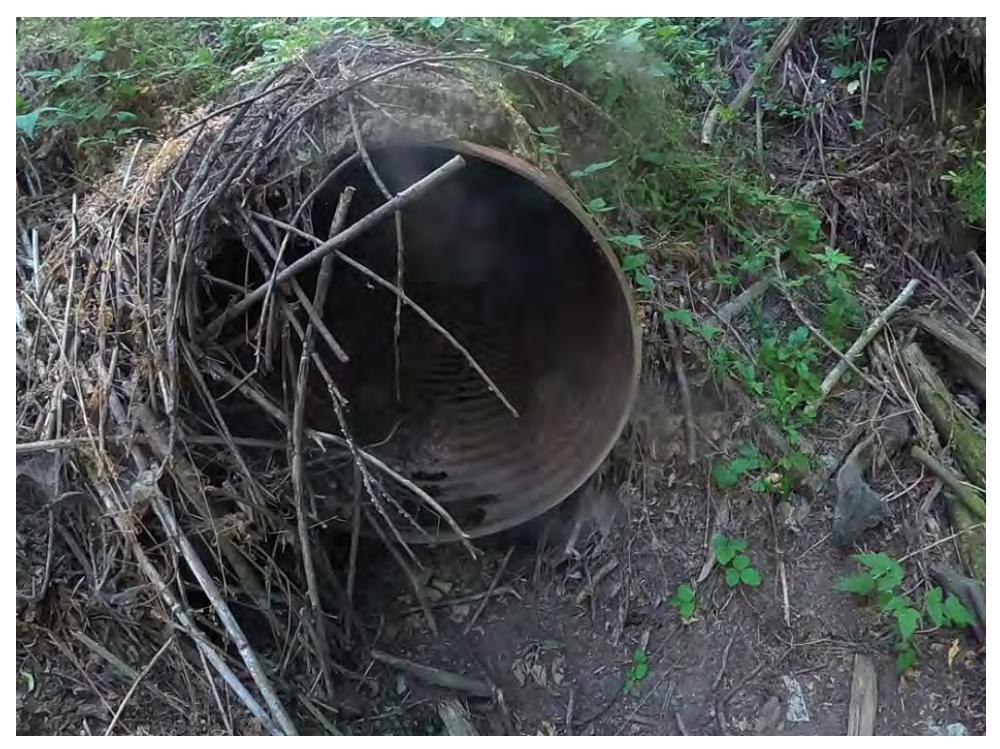
Figure 5-10: Southern Pipe System Outfall (From 6th Street).

Tideflex valves are less expensive than check valves. However, as shown in Figure 5-10, these outfalls are susceptible to debris accumulation. If enough debris accumulates on either type of valve, they may not fully open during a storm to let water out of the pipe system. This may cause backwater into the system and result in flooding in Villa Grande. Mitigating for debris accumulation would require some form of debris rack, which would likely entail building a concrete structure at the end of the pipe.

Alternatively, traditional valves could be used by placing a new structure along the pipes upstream of the outfall and attaching a flap gate valve inside of the structure. Issues with debris accumulation and construction on the banks of the Russian River could be mitigated and this type of installation could improve access to the valve for maintenance.

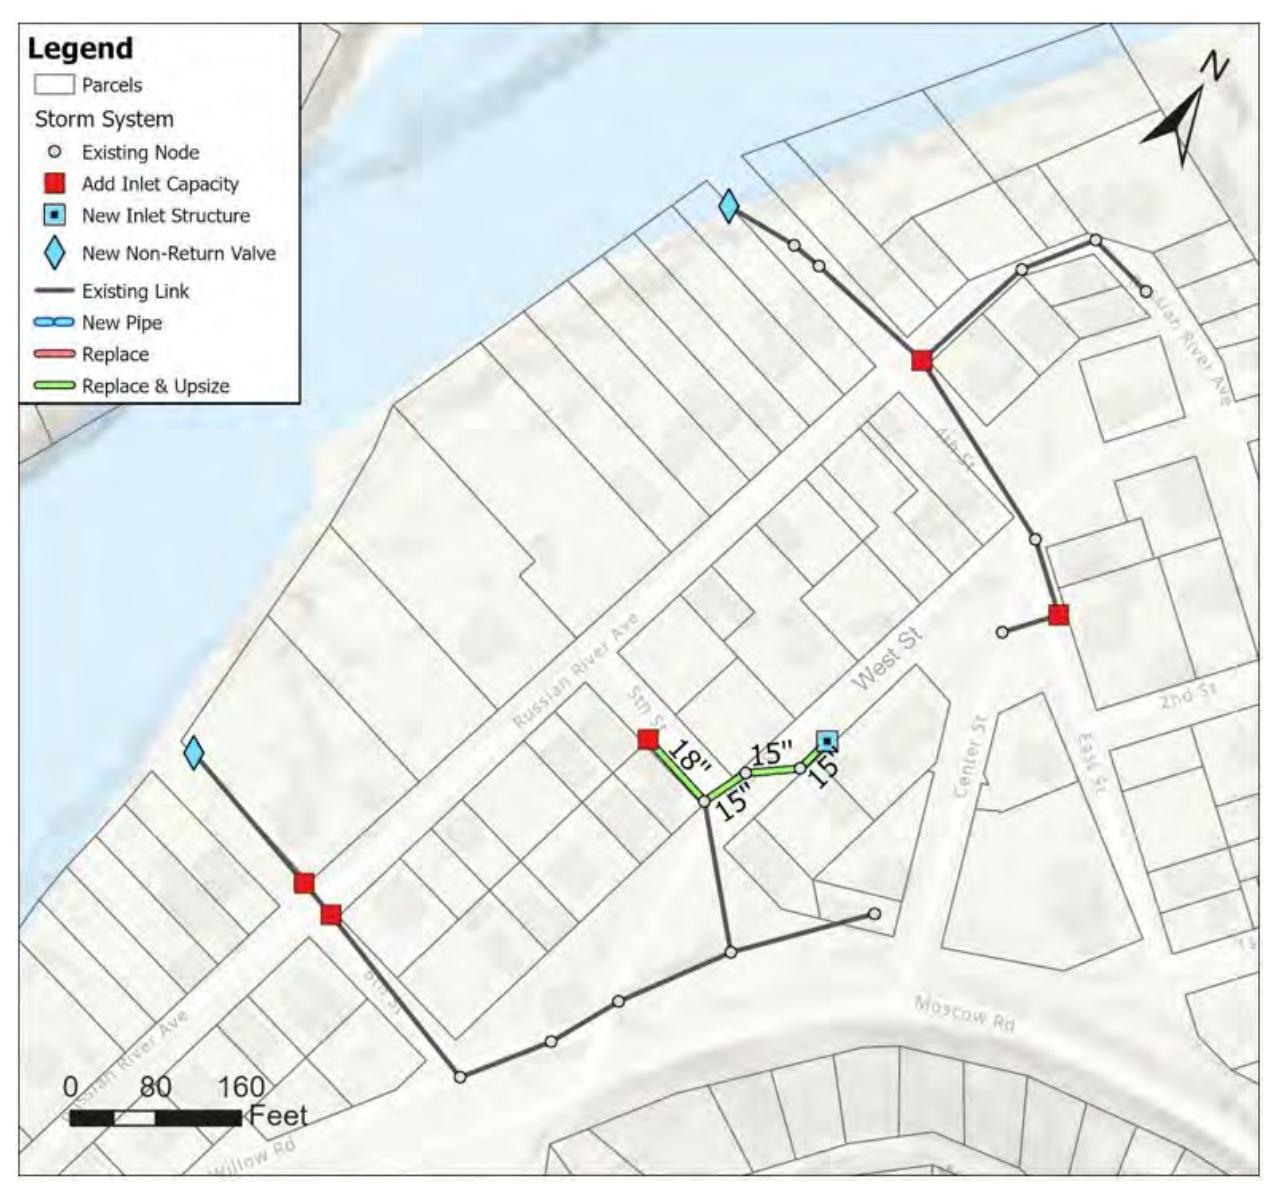
Figure 5-13: Villa Grande Pipe Conveyance Capital Improvement Alternative S-1 Map

Alternative S-1 would minimize the extent of pipe replacement and address the most urgent needs in the system. Improvements would be focused on eliminating flooding identified near the Post Office and on 5th Street. This would also add inlet capacity in the areas with the greatest need. The alternative is illustrated in Figure 5-13. Pipe capacity improvements are summarized in Table 5-6 (Non-return valves are shown in these figures, but are not part of the pipe system alternatives).

This alternative reduces flooding identified by the model along West Street and 5th Street by simply upsizing the existing system and adding inlet capacity where it's needed most based on the analysis of existing inlet capacity. In addition to pipe capacity improvements, this alternative

would add six grate inlets to the system to enhance the flow of runoff into the pipes and reduce nuisance flooding.

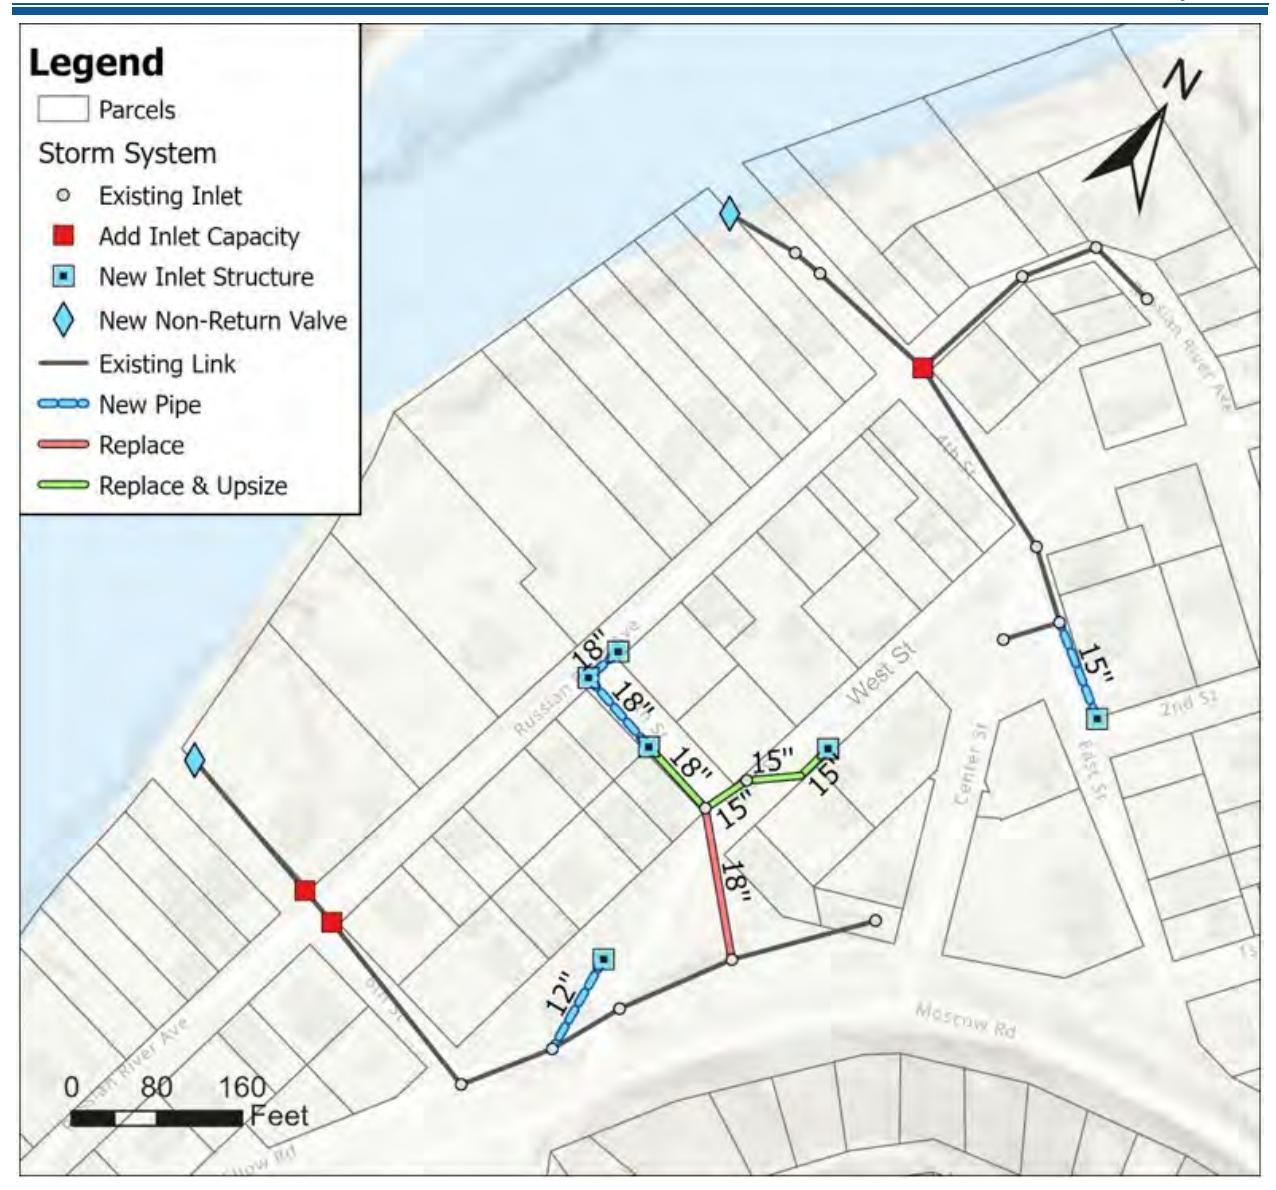
Figure 5-14: Villa Grande Pipe Conveyance Capital Improvement Alternative S-2 Map

In addition to pipe capacity improvements, this alternative would add up to 11 grate inlets to the system to enhance the flow of runoff into the pipes and reduce nuisance flooding.

This alternative is illustrated in Figure 5-14. Pipe capacity improvements are summarized in Table 5-7.

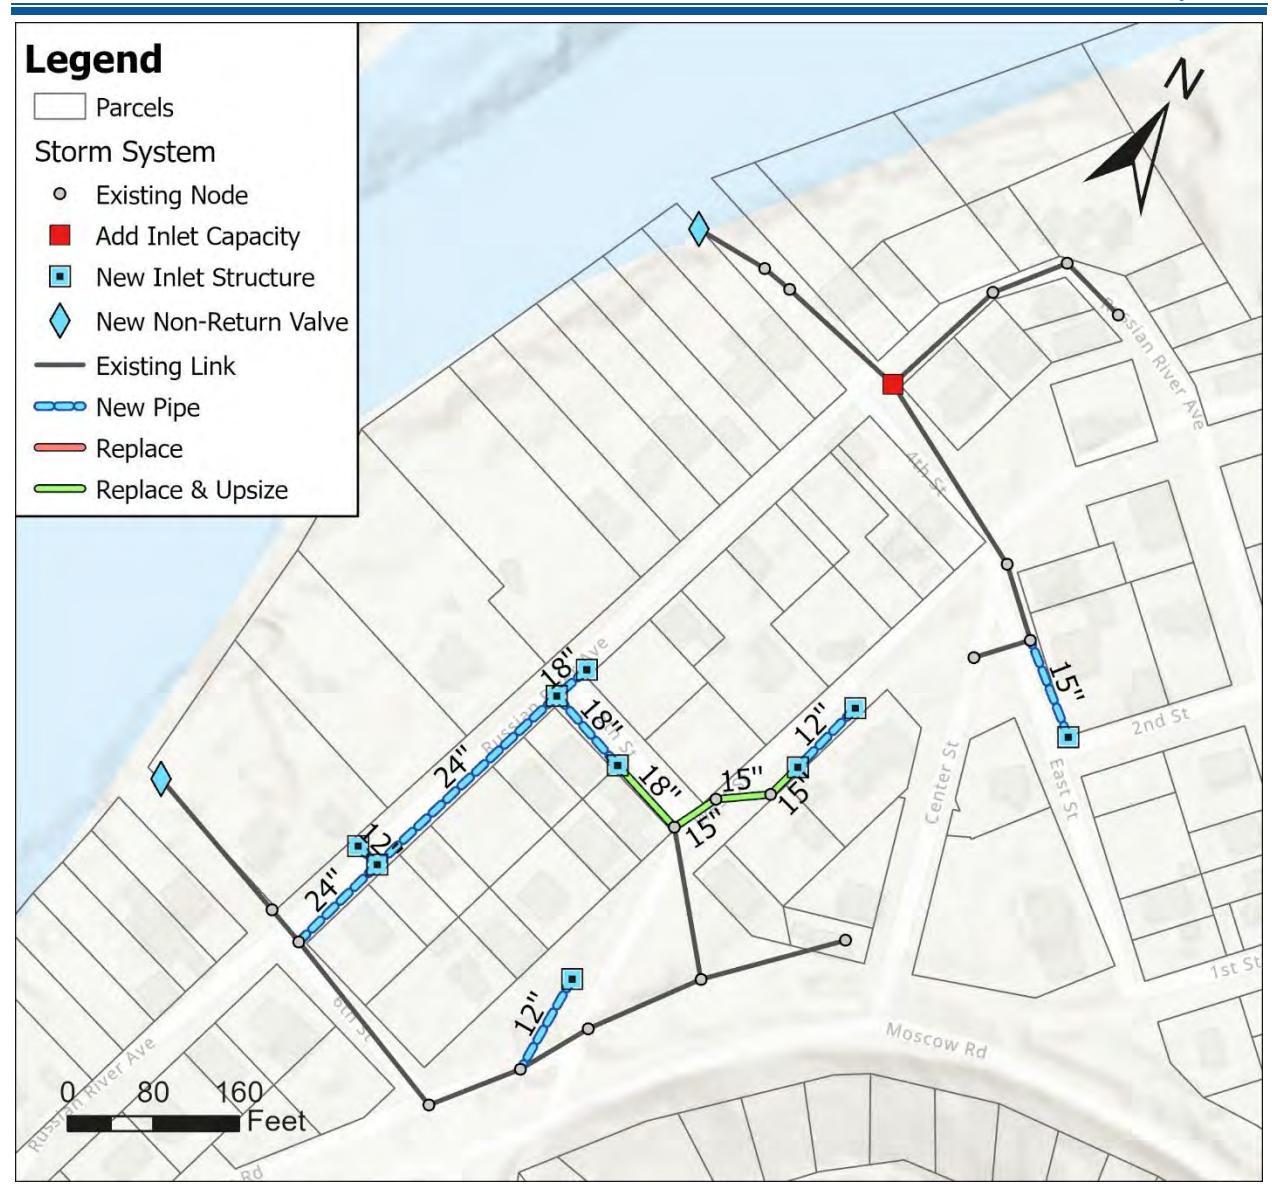
Figure 5-15: Villa Grande Pipe Conveyance Capital Improvement Alternative S-3 Map

In addition to pipe capacity improvements, this alternative would add 11 grate inlets to the system to enhance the flow of runoff into the pipes and reduce nuisance flooding.

This alternative is illustrated in Figure 5-15. Pipe capacity improvements are summarized in Table 5-8.

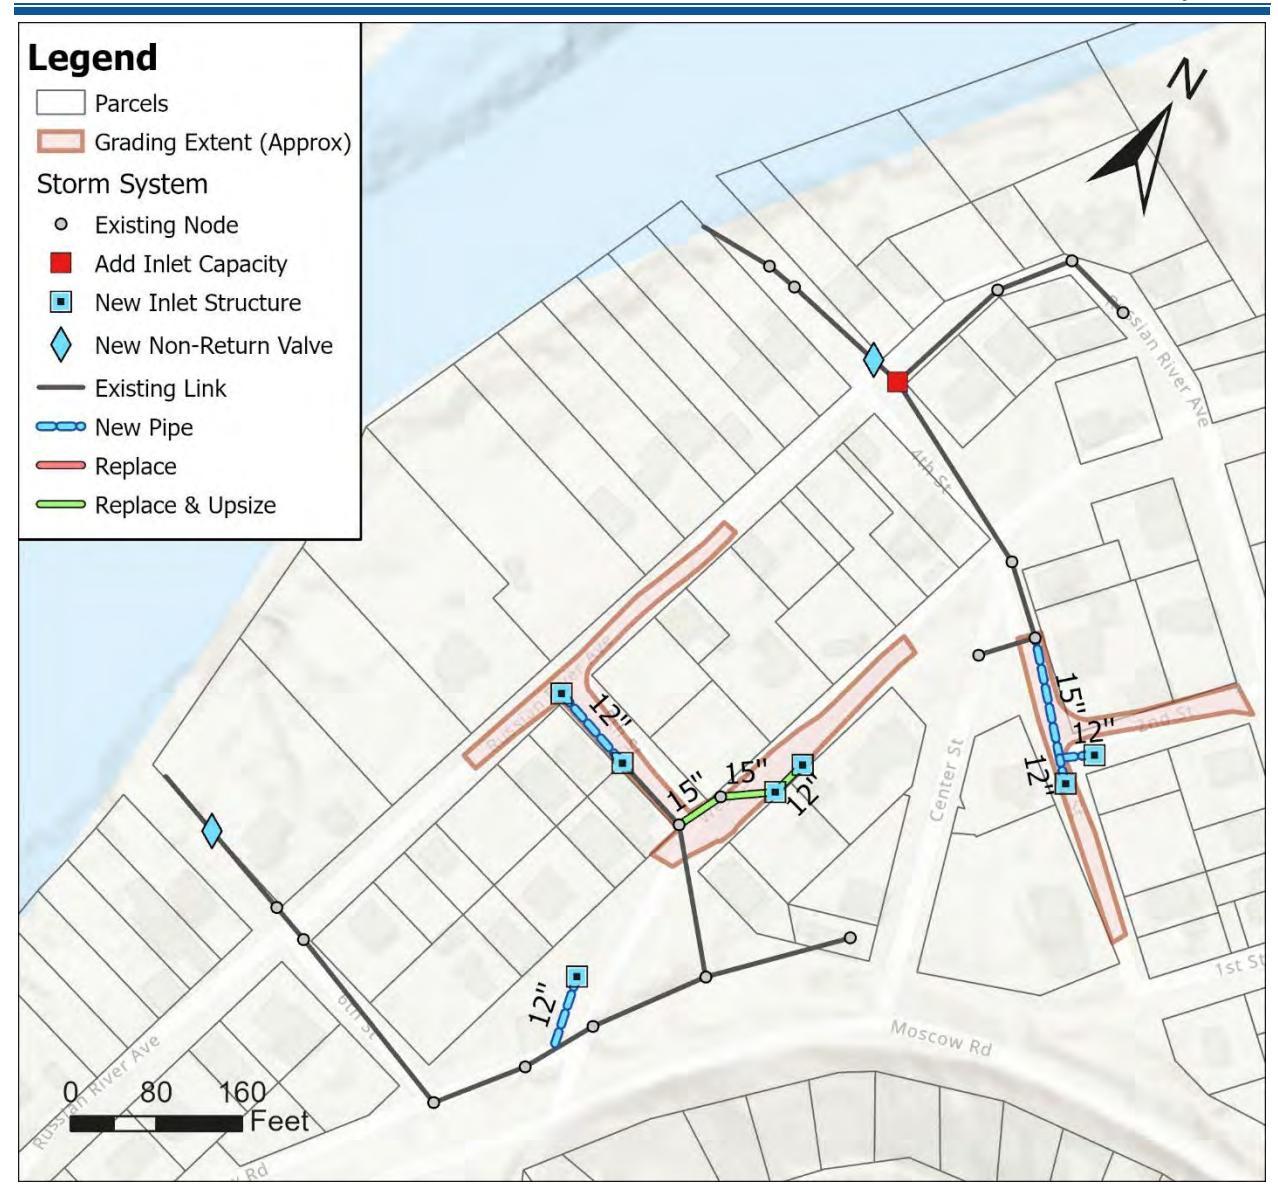
Figure 5-16: Villa Grande Pipe Conveyance Capital Improvement Alternative S-4 Map

An overview of this alternative is shown in Figure 5-16, with pipe system improvements summarized in Table 5-9.

This will still require the installation of 12 new 2'x3' (minimum) drain inlets distributed throughout the area to more efficiently capture drainage from the surface and reduce ponding depth and spread in roadways and properties during a storm. In certain areas where runoff concentrates heavily, inlets would be dual, side-by-side inlets to remove water from the surface more quickly.

This alternative also does not increase the size of certain existing pipes. The system extension shown in Alternative S-2 recommends 18" pipe on 5th Street. In order to install 18" pipe, however, replacement of the system downstream all the way to the ditch would be required. The preferred alternative instead balances system extension with utilizing existing capacity on 5th Street. Short duration system surcharge is generally tolerable and isn't likely to cause property damage. This project simply extends the 12" pipe to a new low point graded on 5th Street.

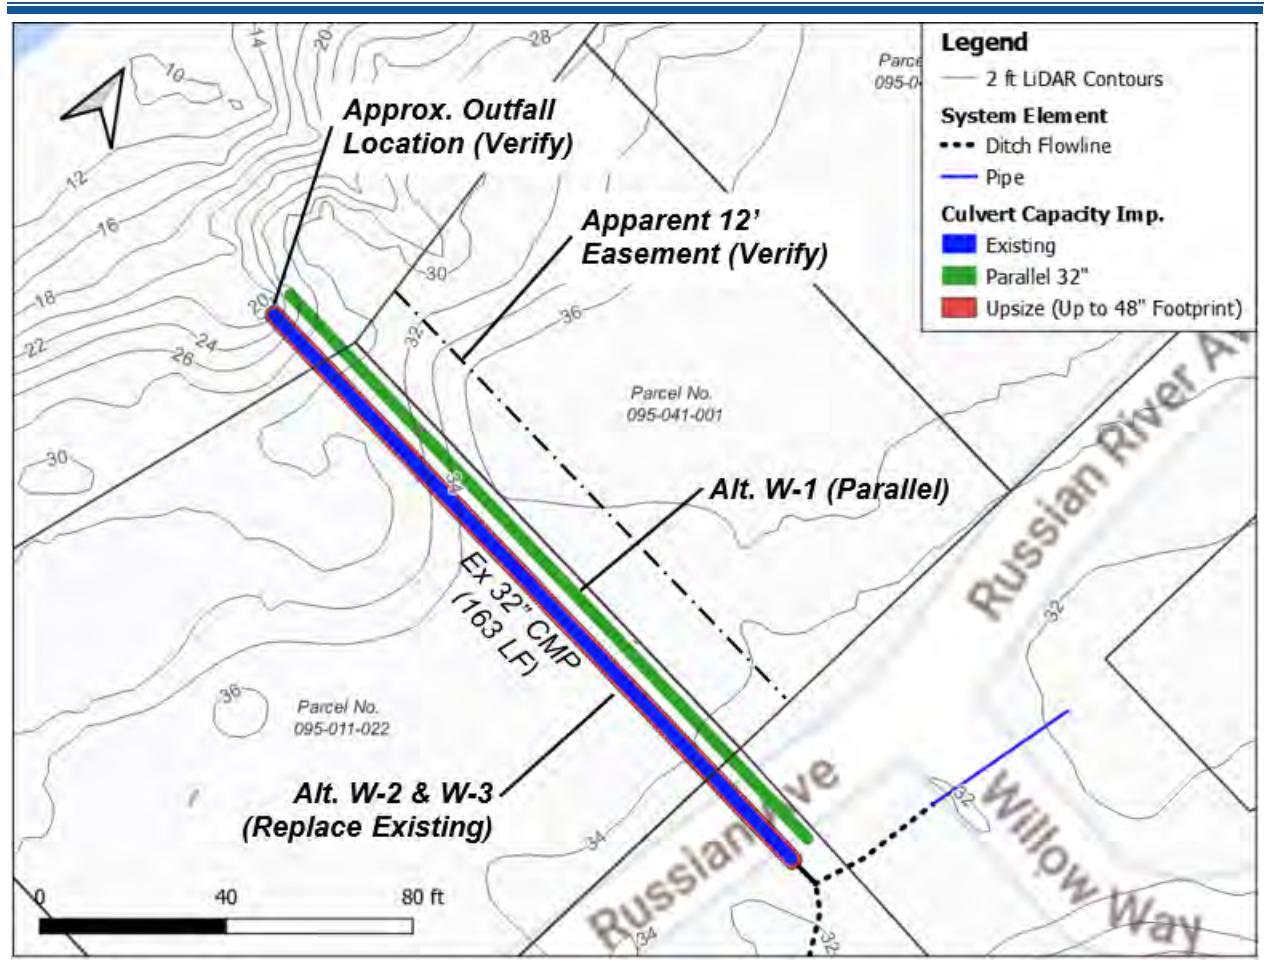
Figure 5-18: Willow Way Culvert Improvement Alternative Footprint Comparison.

The approximate location of this culvert and conceptual footprints of improvement alternatives is shown in Figure 5-18. It's likely that before choosing an alternative to proceed with, more detailed topographic and boundary survey will be required. Access to the outfall of this culvert appears to be provided by a 12-foot easement, based on assessor maps (shown in Figure 5-19). However, upon superimposing the surveyed culvert inlet and the approximate location of the outfall on the GIS parcel data, it appears the existing culvert may not be located within the easement at all. This would place the existing pipe entirely on private property.

The actual placement of a new or parallel pipe will most likely depend upon the actual size and location of existing easements. Without boundary survey, this is difficult to predict beyond superimposing GIS parcel data.

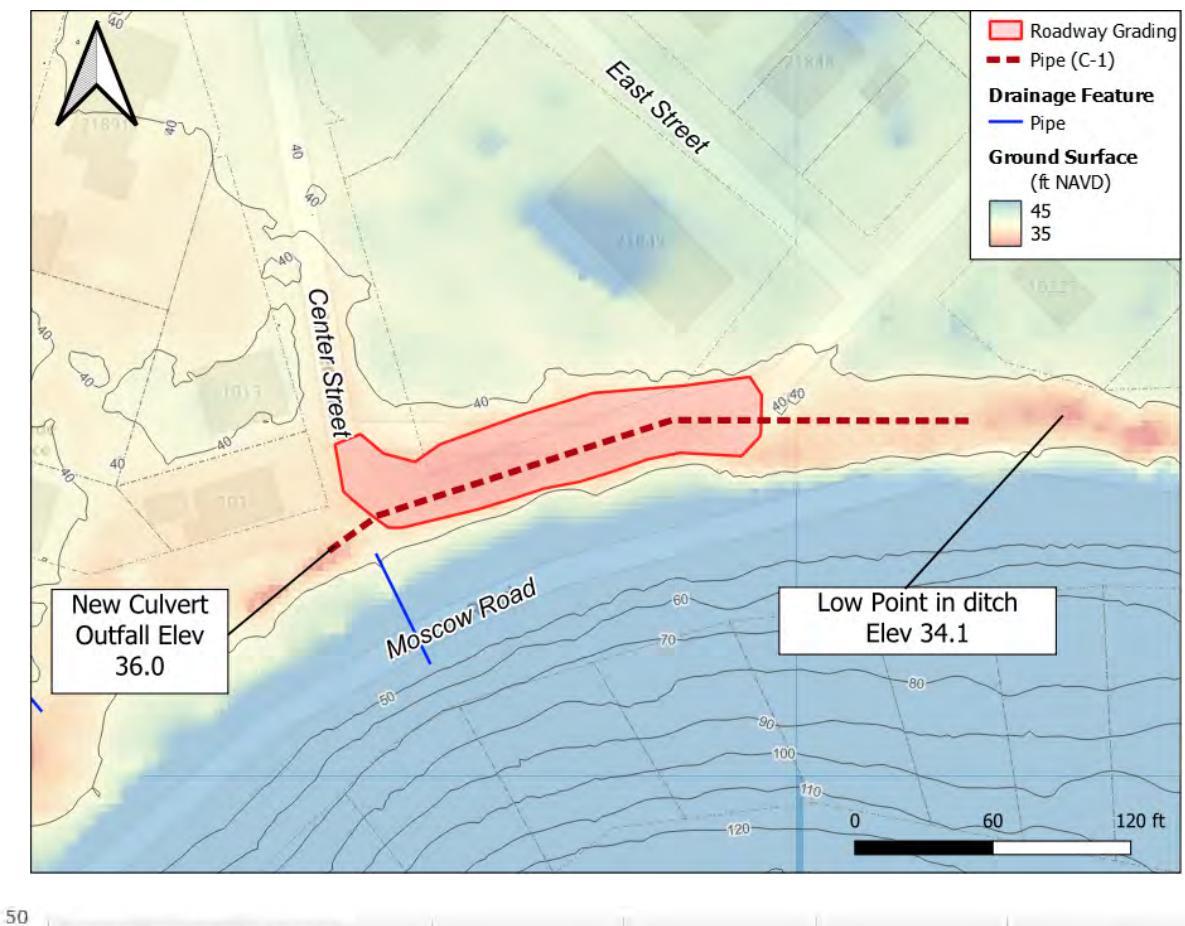
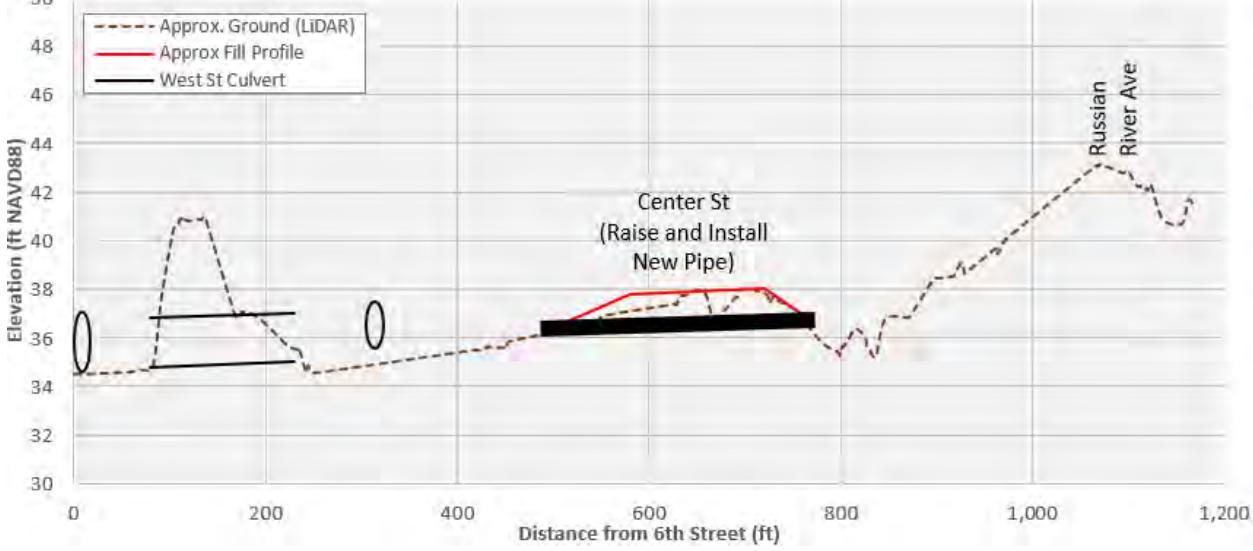
Alternative C-1 is shown schematically in plan and approximate profile in Figure 5-20. This alternative requires a moderate amount of fill material and the greatest amount of new pipe to maintain drainage. Cost estimates for this alternative assume that the roadway must be filled approximately one foot on average in order to provide cover for a 12-inch pipe, extending from the low point east of the road to the ditch line to the west.

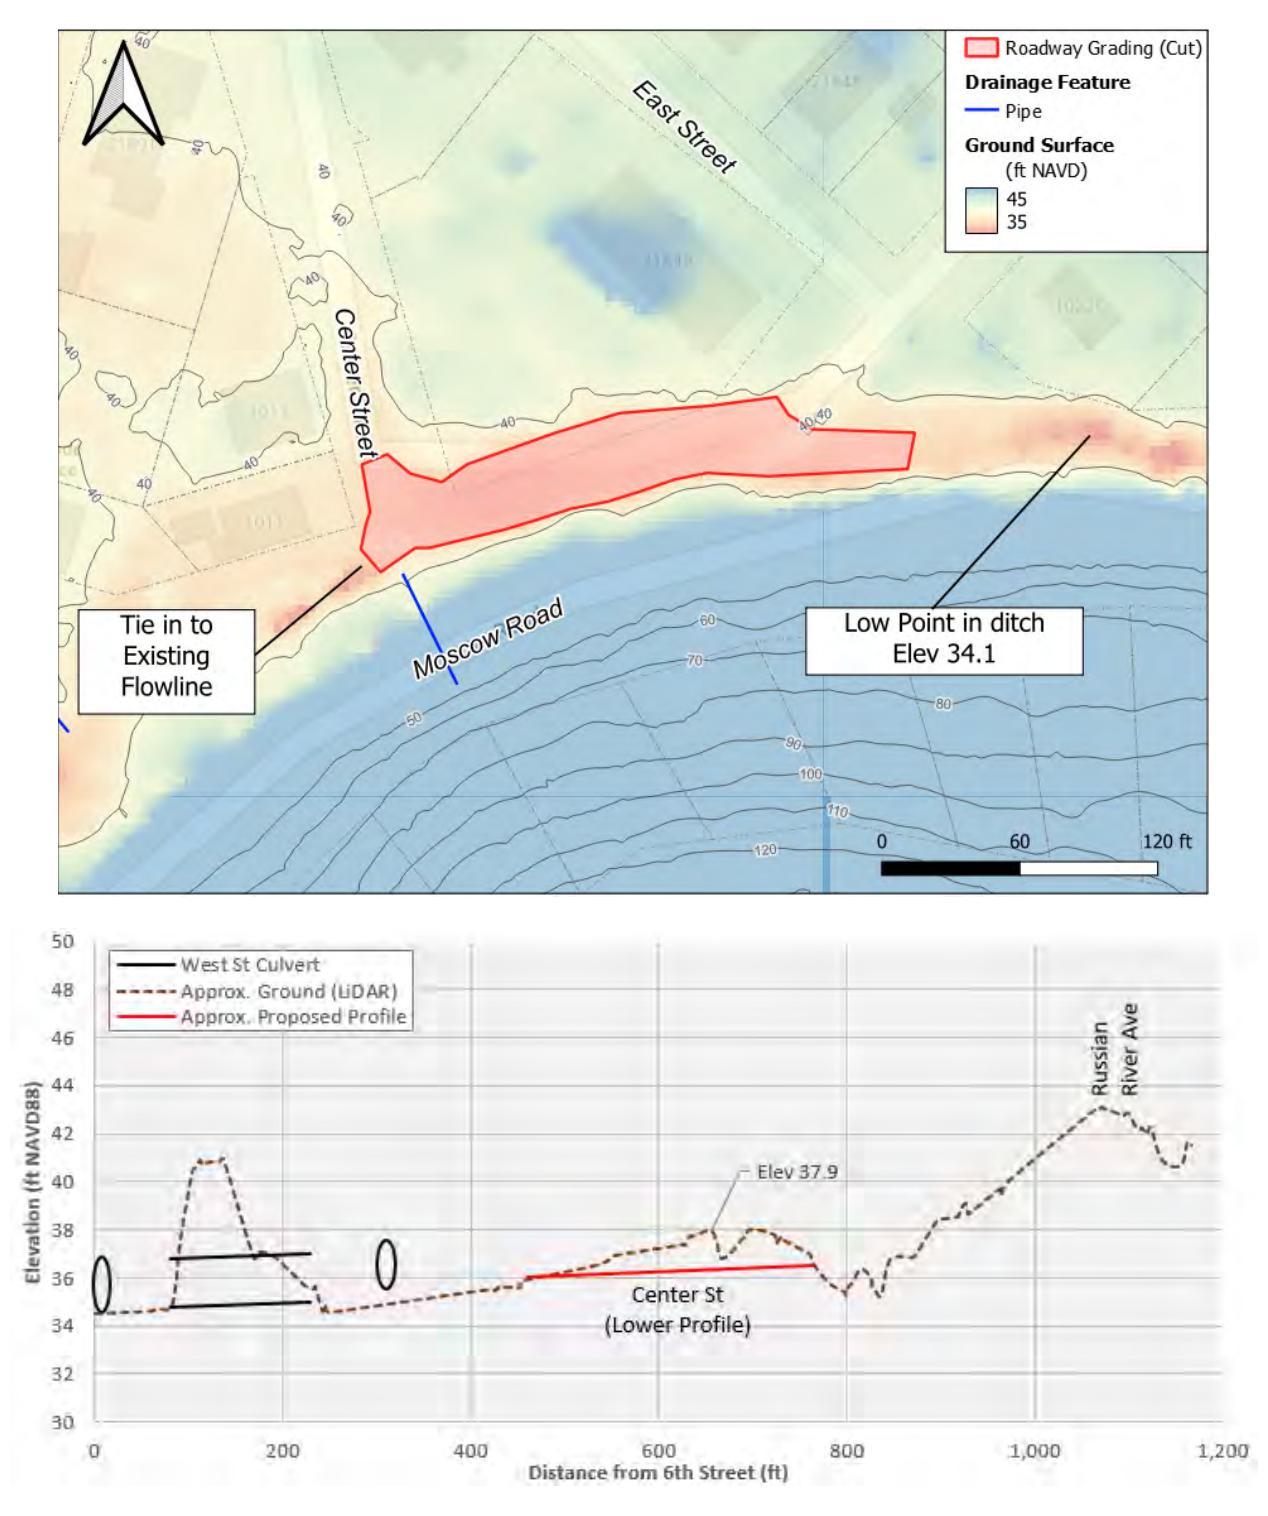
Alternative C-2 is shown schematically in Figure 5-21.

The full scope and cost of this alternative is subject to several factors. Grading may either extend onto private property or require retaining walls on either side of the roadway. On one side, the embankment adjacent to Moscow Road constrains grading and would most likely

require a retaining wall to remain stable. On the north side of Center Street, private property appears to be relatively close to the roadway and would either require a construction easement to daylight grading or a retaining wall to stay out of the property.

This analysis assumes that the roadway must be cut approximately one foot on average and up to 1.5 foot maximum.

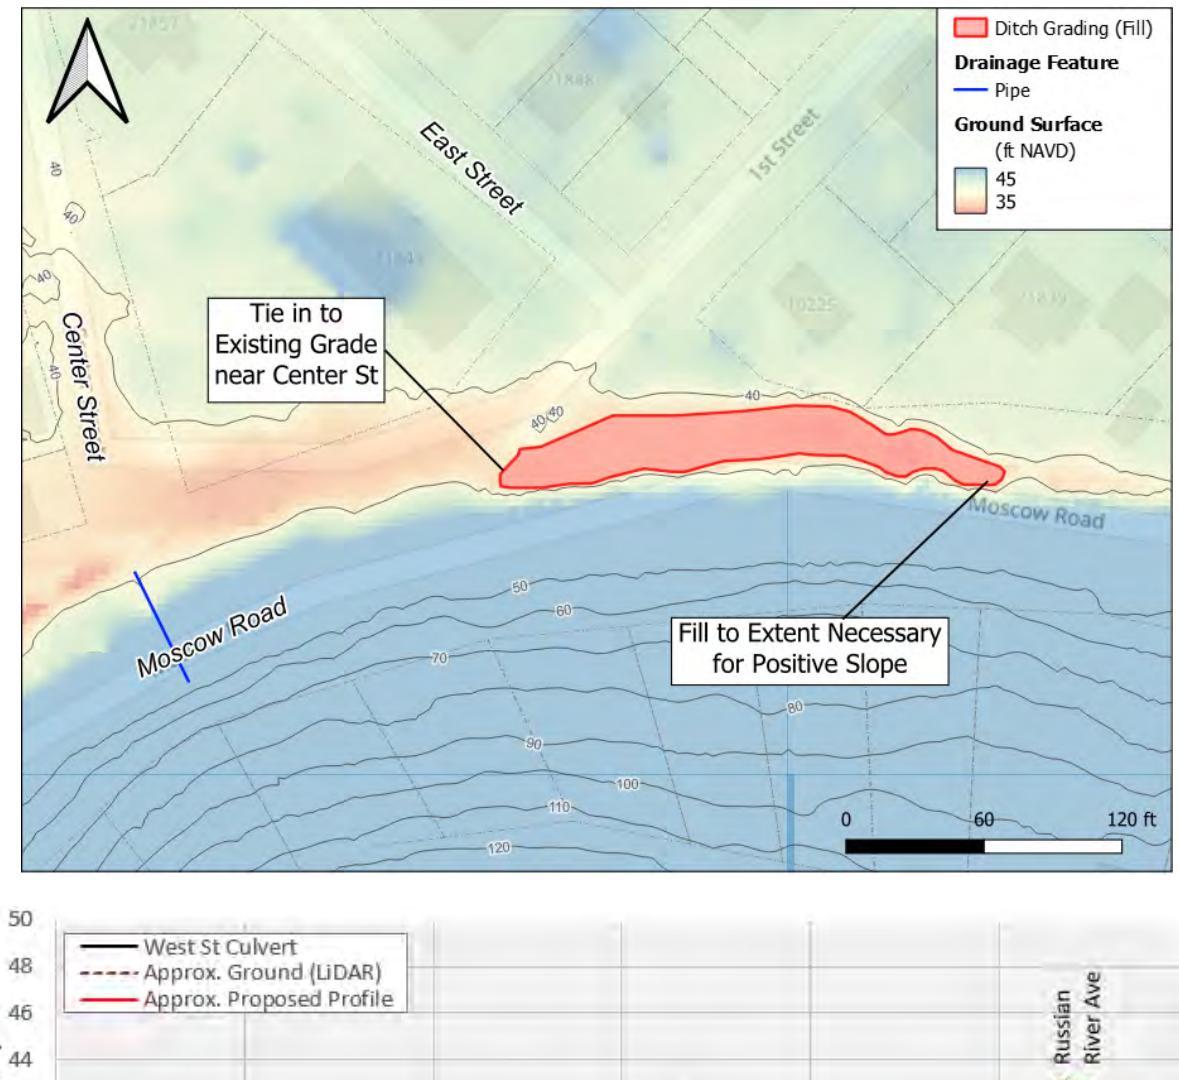
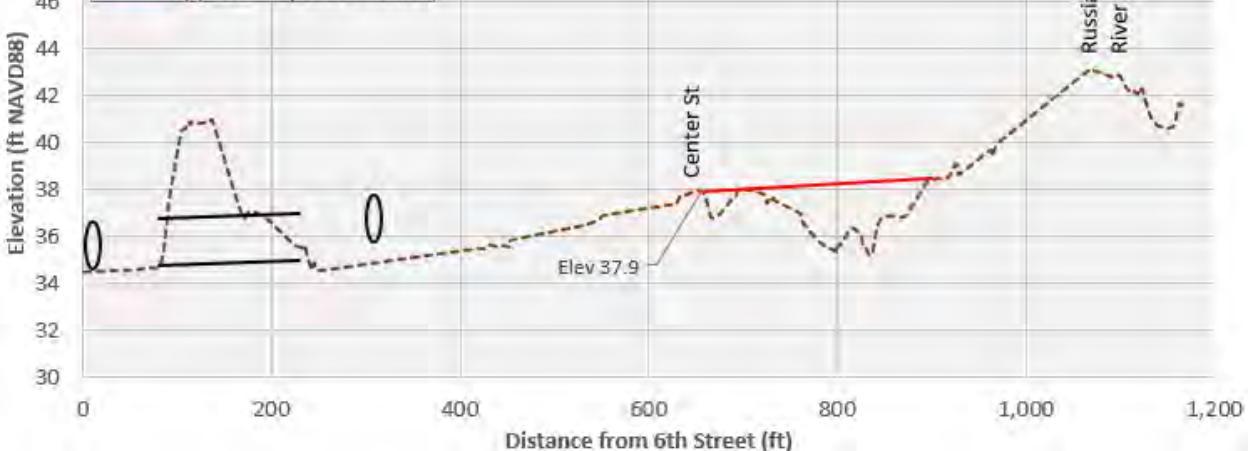
Alternative C-3 is shown schematically in Figure 5-22. This is likely the cheapest alternative to address drainage issues near Center Street. Modeling indicates that a rock-lined v-ditch 1.75 feet in depth with 4:1 side slopes would convey a 10-year event with approximately 0.75 foot of freeboard. A sample section through the low area showing fill and the v-ditch is shown in Figure 5-23.

Based on GIS parcel boundaries and available LiDAR, it appears that grading required for this alternative may remain completely outside of private properties. However, this alternative must be carefully evaluated during later design phases with additional survey available to ensure that this approach is feasible without creating additional shallow flooding on properties to the north.

This alternative also involves placement of about three feet of fill in certain locations. An arborist should be consulted to determine whether this volume of fill might have an impact on root systems of trees around the area where water ponds. Constructing a lined conveyance channel may also require removal of some trees to provide conveyance

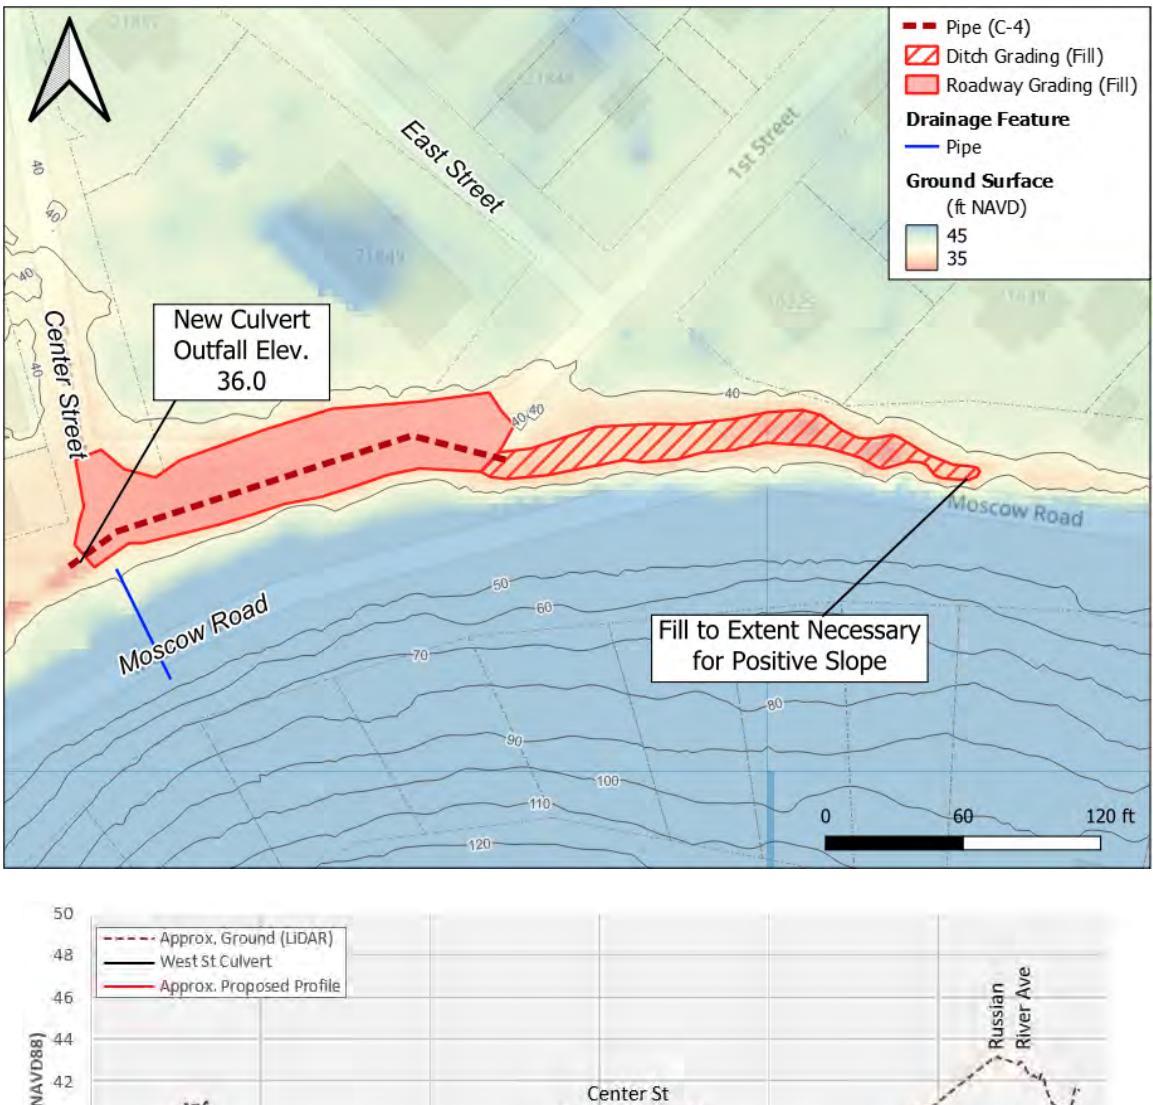
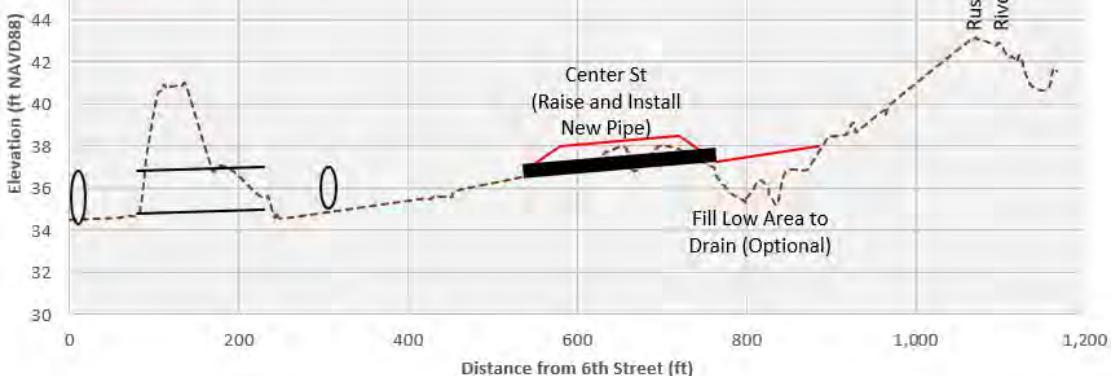
Figure 5-24: Alternative C-4 Plan (Top) and Approximate Profile (Bottom)

Alternative C-4 is shown schematically in Figure 5-24. This alternative is likely more costly than simply filling the low spot but keeps fill more concentrated to the roadway. Fill in the low-lying area would be only to the extent necessary to prevent ponding below the elevation of a new pipe system and may not be necessary if some ponding is acceptable. The pipe system for this alternative would be shorter than that required for Alternative C-1. This still requires verification of property lines and evaluation of the need for construction easement or retaining walls.
